Project Report: Canyon Lands Fort Bottom Trails  
Field Review, Analysis, Conclusions, and Recommendations  
Henry Shovic, PhD  
Rocky Mountain Cooperative Ecosystems Study Unit  
Mar 4, 2009

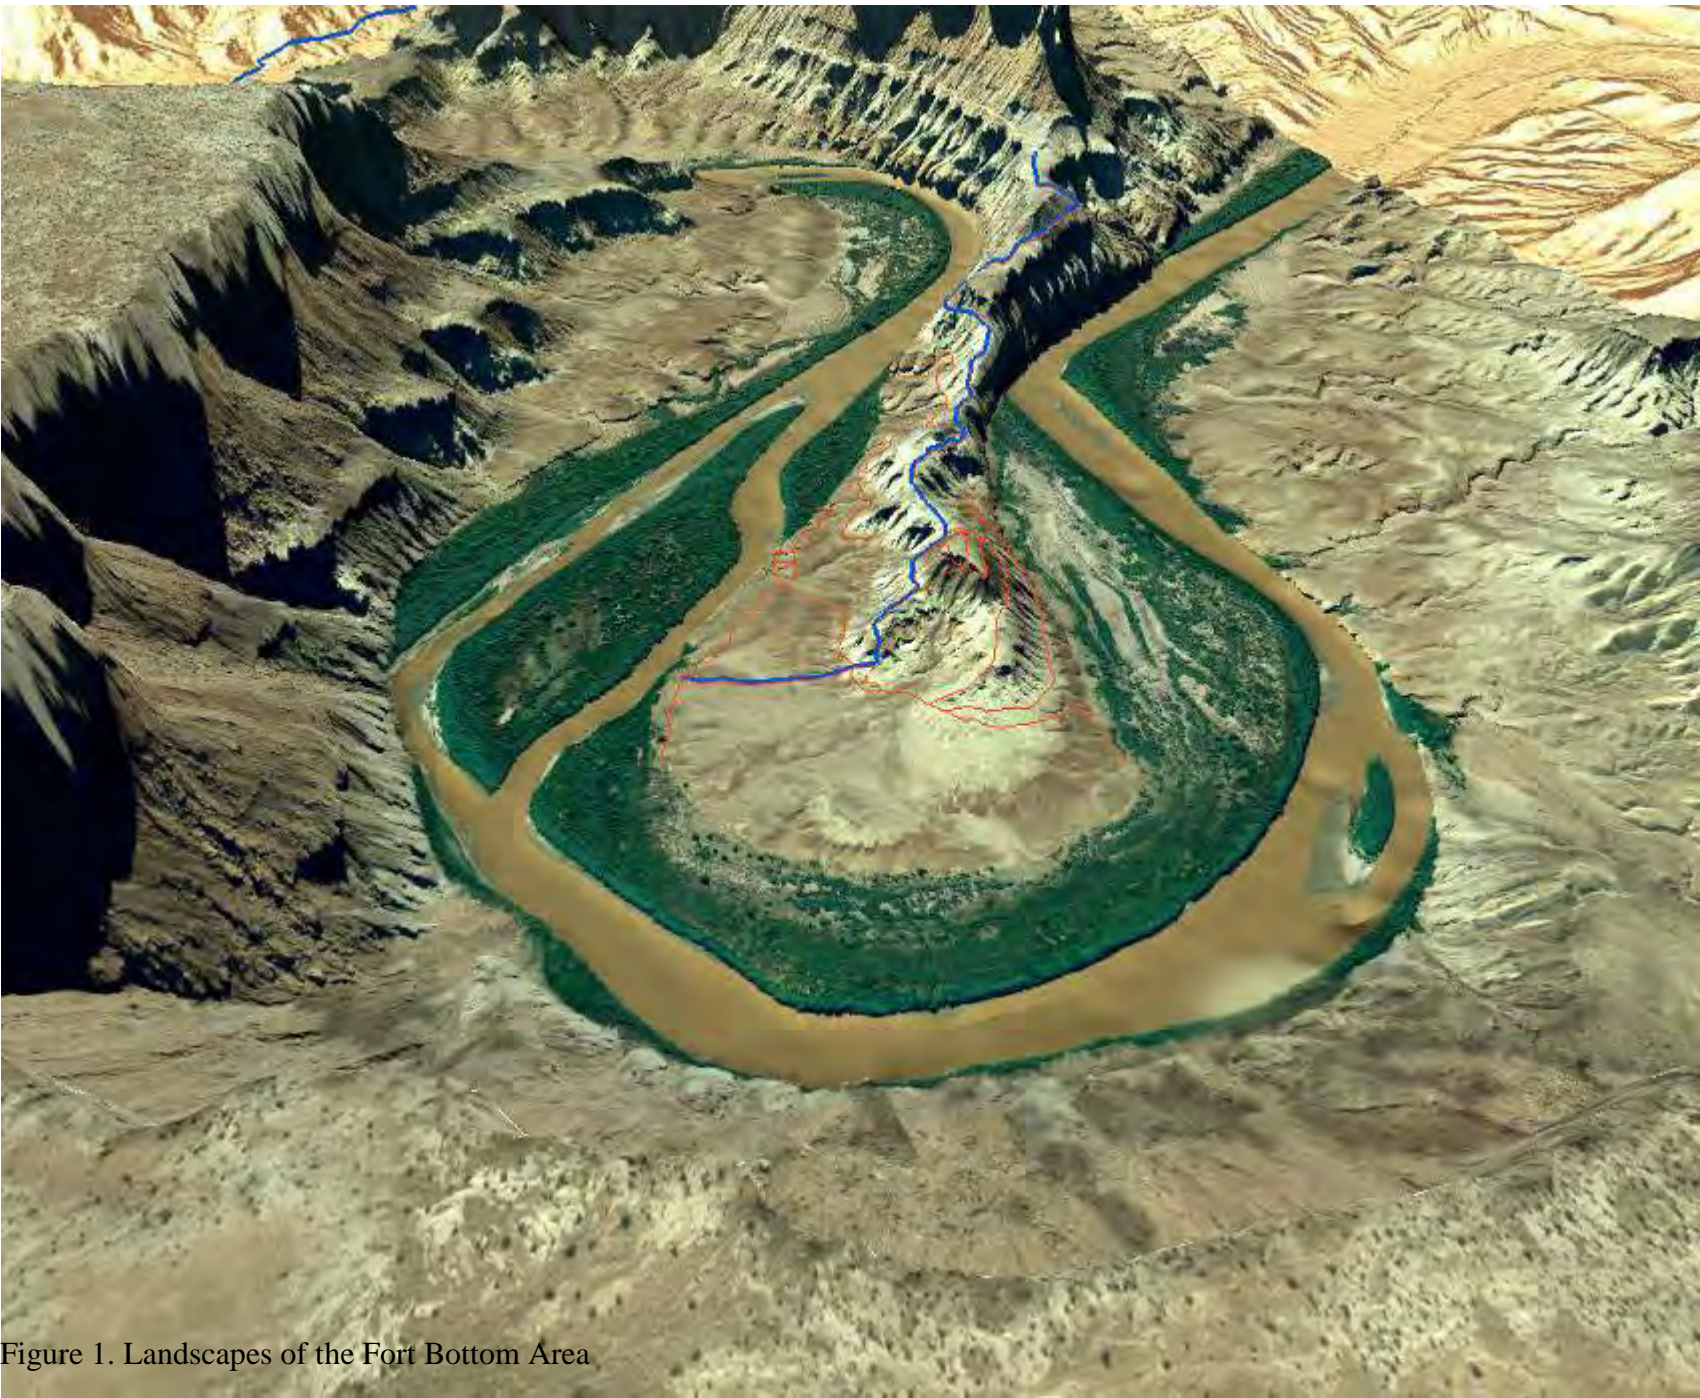
Figure 1. Landscapes of the Fort Bottom Area

Figure 1 shows the landscapes of the trail area. Slopes are gentle to steep, with the main trail (blue) following a rocky ridge to the river, and numerous social trails (in red) on steeper slopes. The underlying landform is an eroded, colluvial slope having little vegetation. The gently-sloping alluvial “bottom” is heavily vegetated with Tamarask and other shrubs. This area can be reached by a primitive and difficult 4WD road, which limits user density. However, the Green River provides most access, and users from the river are probably responsible for most social trail development.

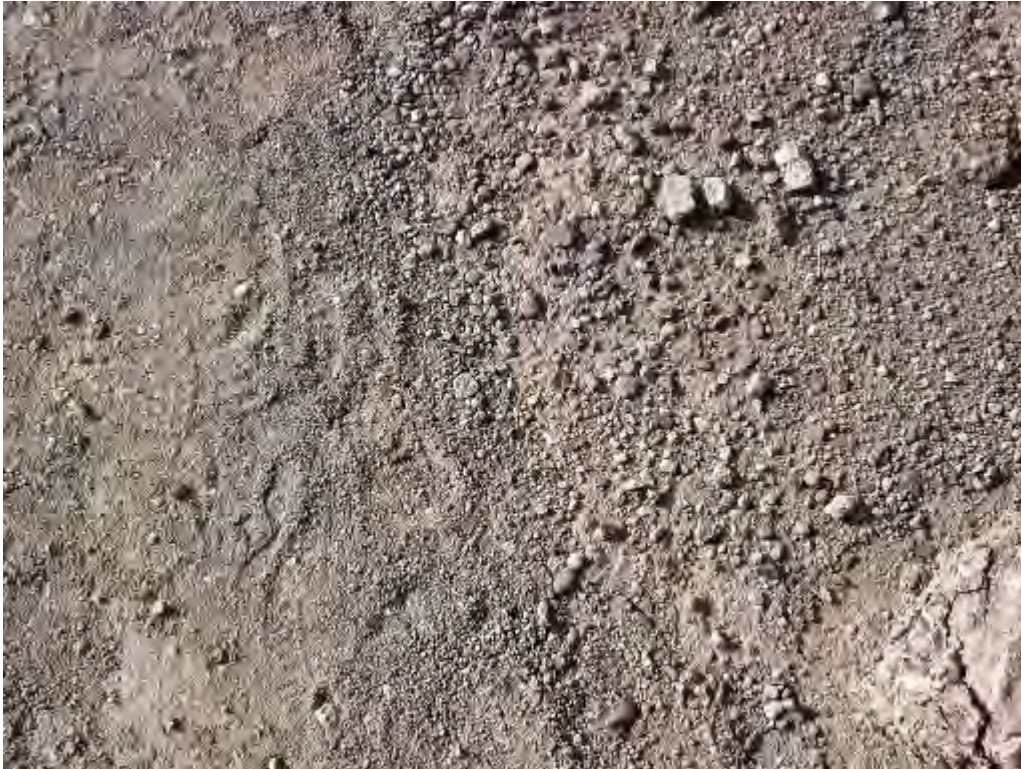
The San Juan County soil survey shows most of the area as either bedrock or residuum weathered from sandstone (Figure 2). Surface texture is rated as absent or gravelly loamy sand. However, based on the field review, soils on trails are gravelly (primarily on the main trail) and silty on the southern non-system trails. The area mapped as “residuum weathered from sandstone” is actually primarily poorly-indurated siltstone, eroding in a “badlands” manner. This shows as lighter gray areas in Figure 1. Lower slopes are covered with desert pavement, consisting of small planar gravels covering silty residuum. This “pavement” is quite fragile, and is easily disturbed by walking.

Soils on the Main Fort Bottom Trail eastern part – from field review

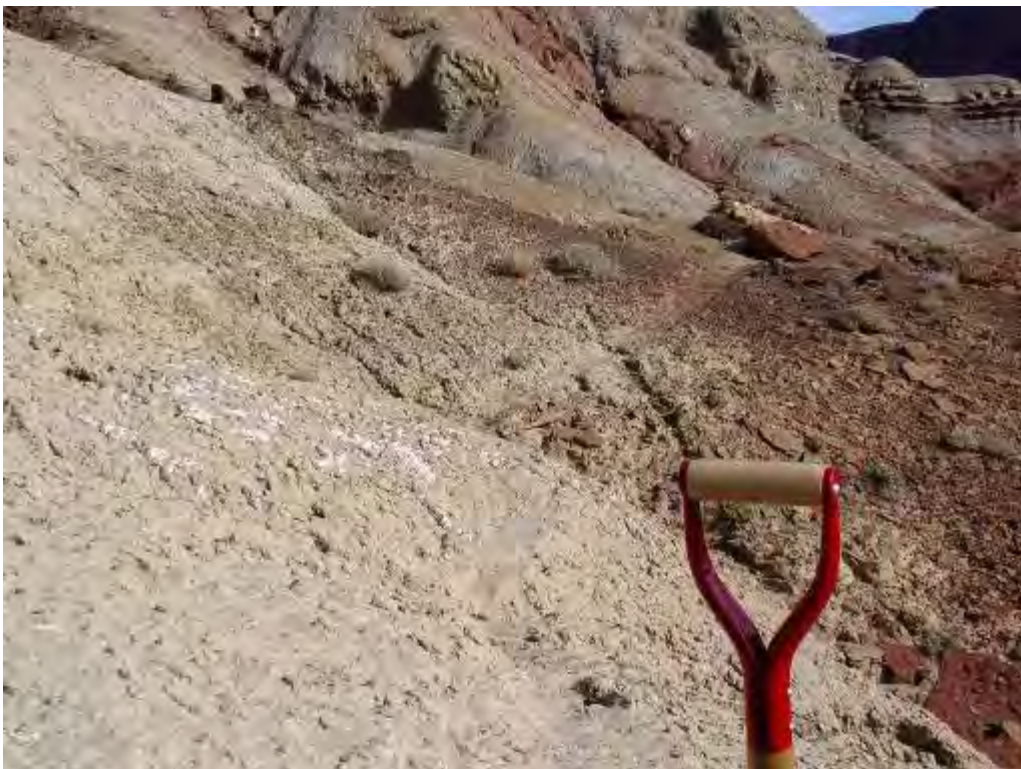
Off-trail soil biologic crust is intermittent, with an average of 20% surface cover. Crust is apparently absent on steeper slopes, probably because of rapid erosion and deposition.

Soils on the non-system trails on the southern side, showing absence of bio-crust – from field review

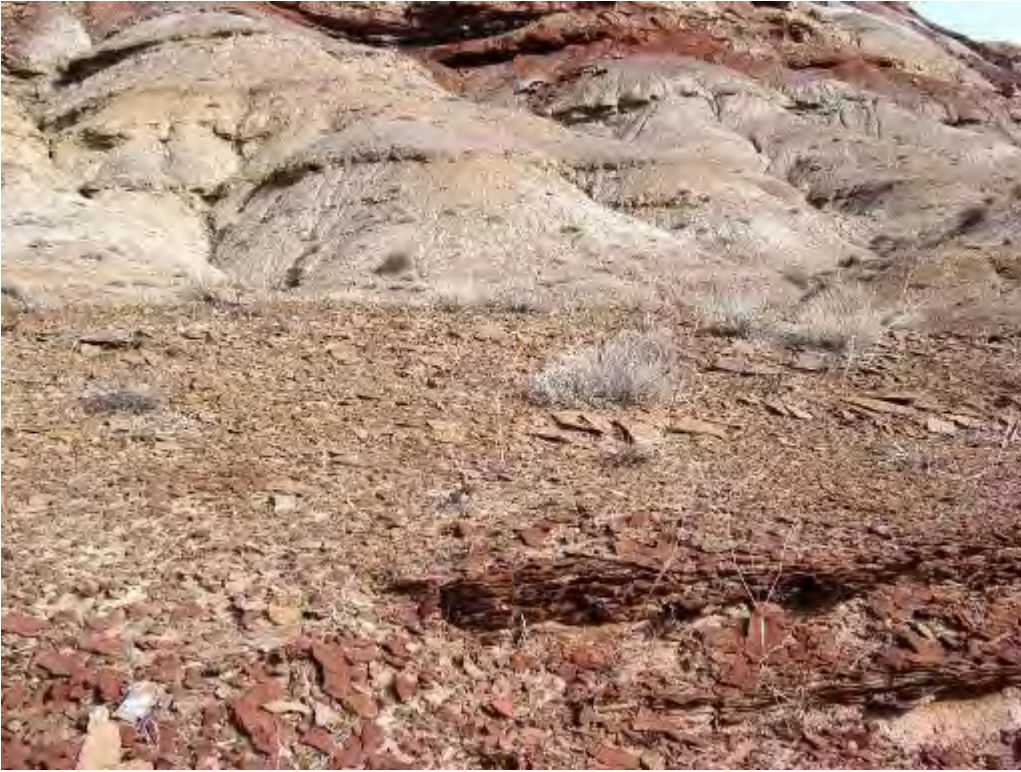
Desert pavement on relatively-stable parts of the western “badlands” area.

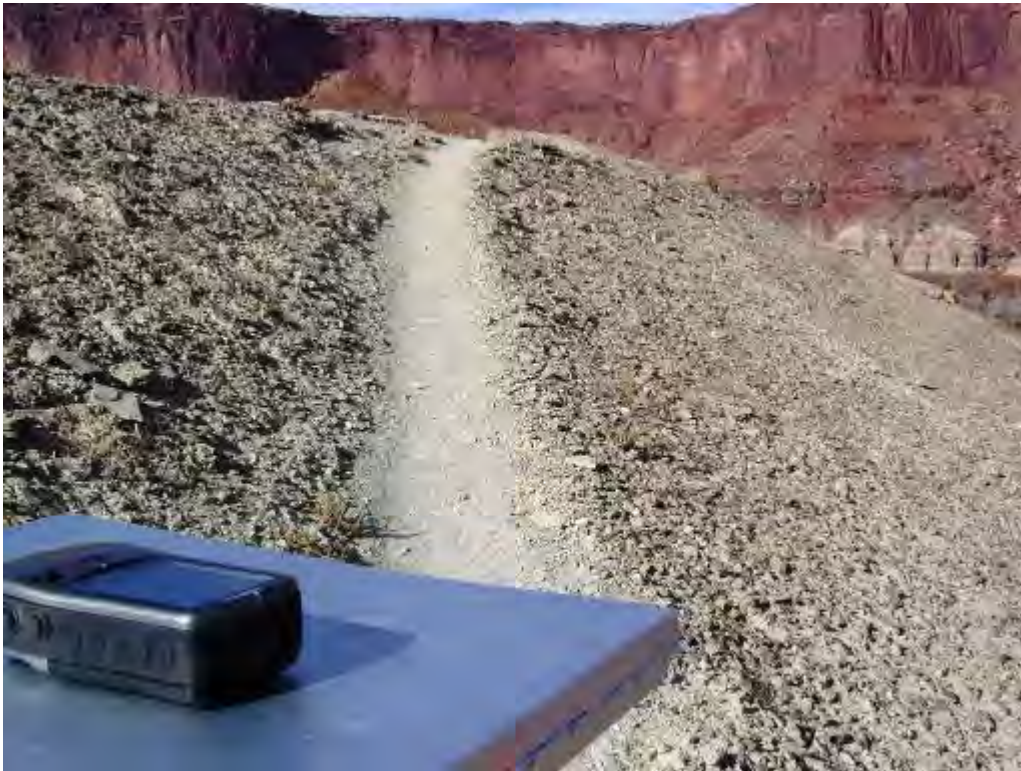
Trails having “Low” sensitivity require little maintenance. They are relatively stable (either on bedrock, mechanically stabilized, or in relatively-stable colluvium).

A trail having “Low” sensitivity. Slopes are gentle, and soils have a stable matrix of mixed materials.

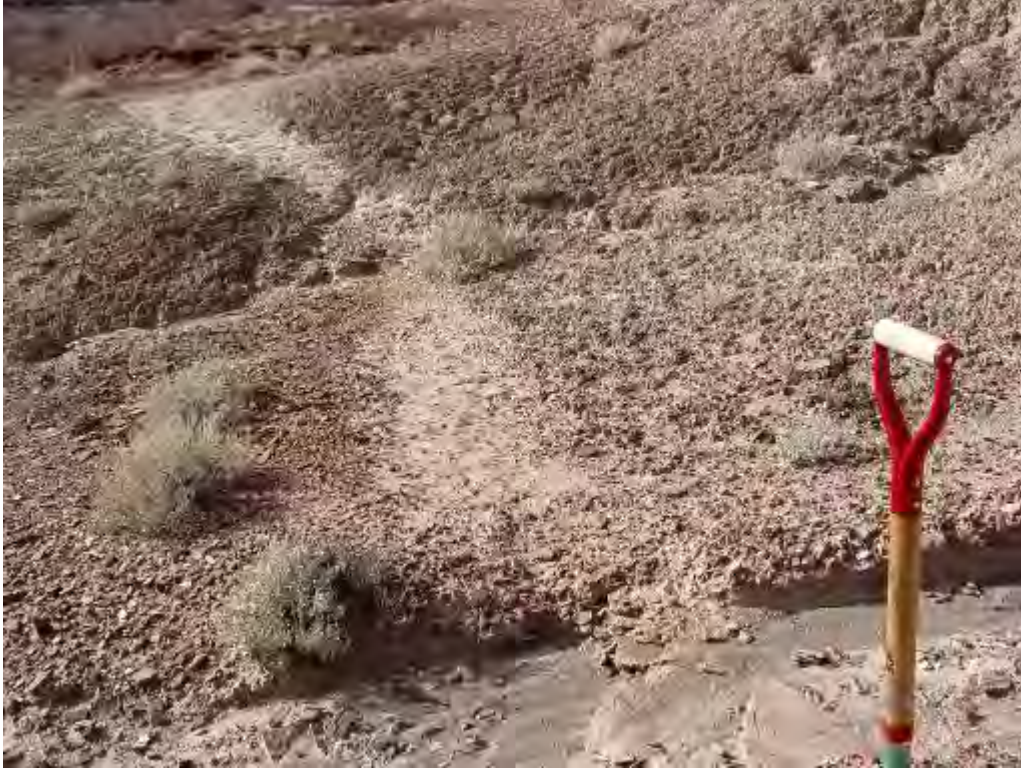
Trails with “High” sensitivity are unstable even with low use, and are likely to become very erosive if subjected to high, sustained use. They have potential for actively damaging resources, both on-site (soils, vegetation), and off-site (sediment, trail widening). They should be stabilized along their entire length, given additional maintenance, or closed.

Trail having “High” sensitivity.

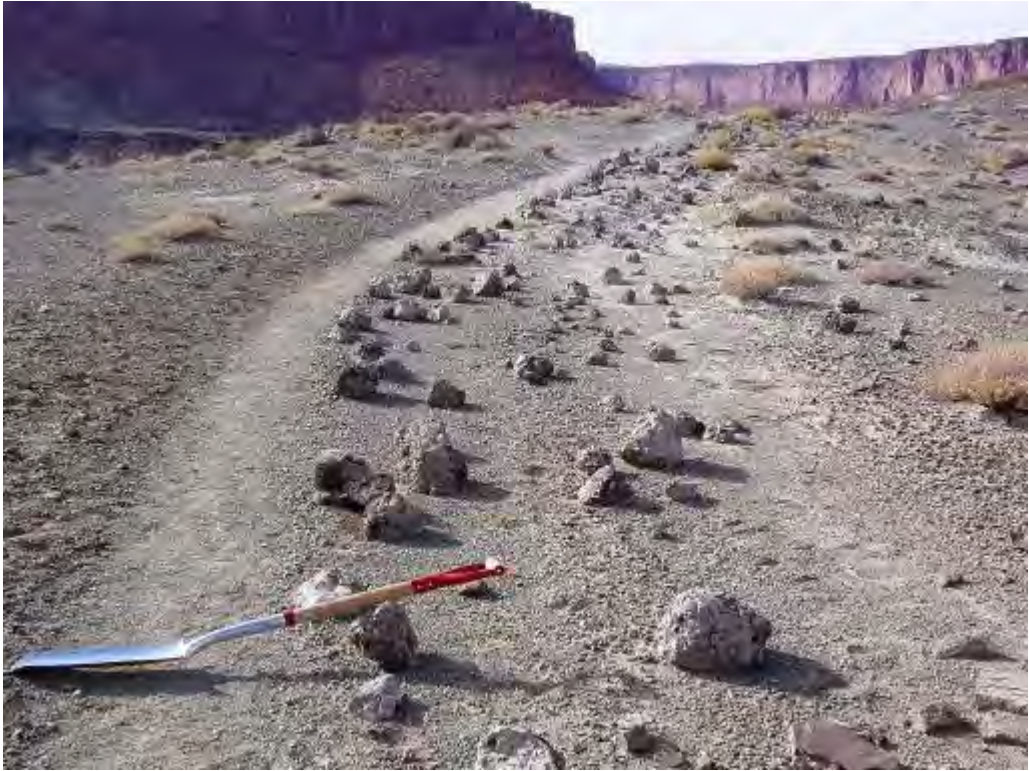
Rock Borders

Rock borders are effective at keeping visitors on the Fort Bottom Main trail. On other trails rock barriers are generally small and ineffective (probably because of the “primitive” management goals in the area, and absence of readily-available rock). Puncheons, though an effective way of deterring use for some visitors, are probably not very effective since tread erosion is not a large factor here and side-slope slough probably will cover them in a short time.

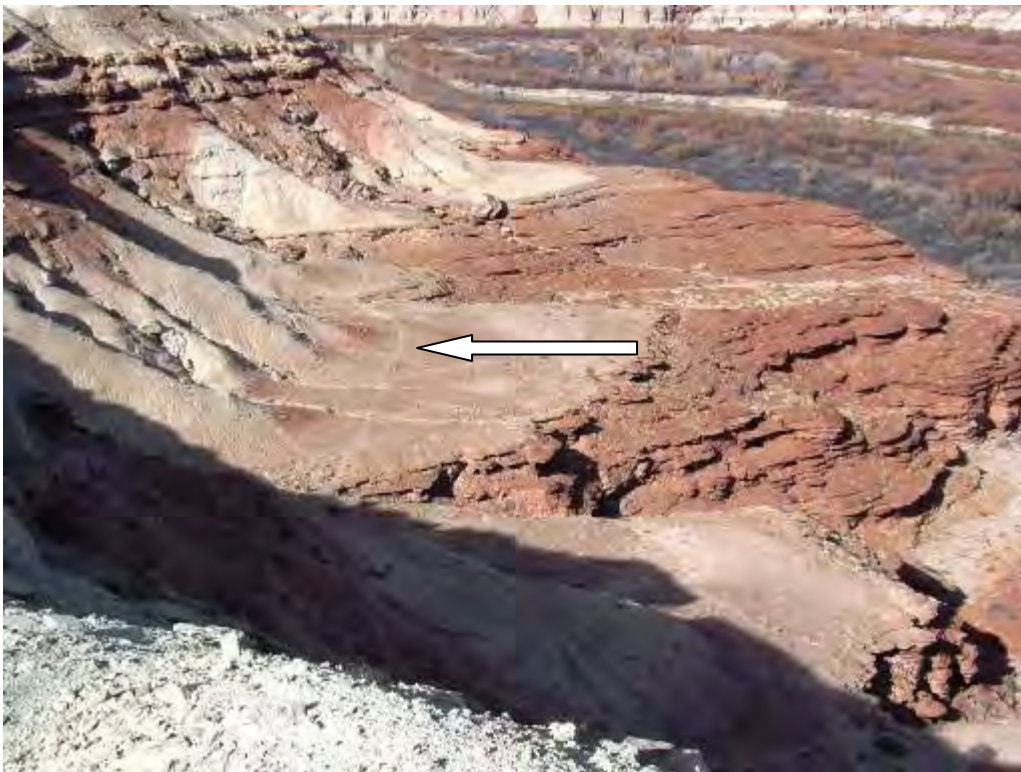
Spur3 Trail

The Spur3 trail is also relatively stable, and is not being widened, but is located in erosive material. It is highly visible, and appears to be located on steep slopes (Figure 5) but actually “snakes around” on gently-sloping benches.

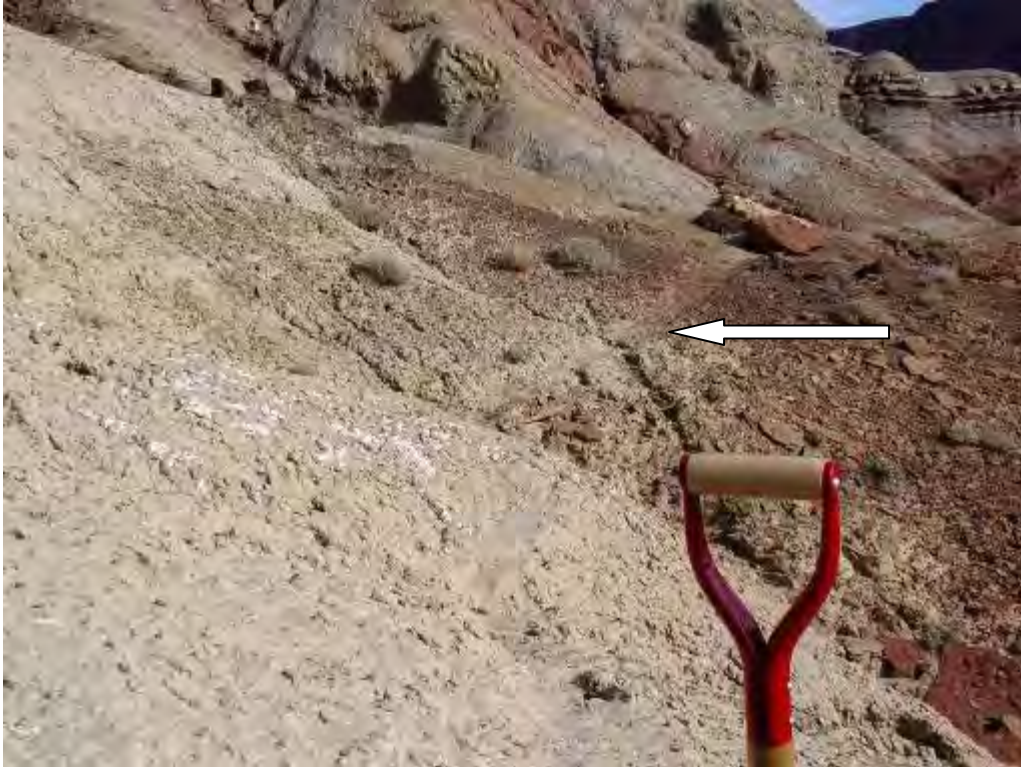
Spur4, Spur5, and Cirque 2 trails are rated as being in “Fair” condition. This is probably correct, as they are in a truly “badland” landscape. The trail itself was actually difficult to find in some places (Appendix One has the GPS track). The trail prism is probably covered by eroding material every year. It was hazardous to traverse in places, especially above steep washes.

Fort Bottom Trails Cirque 2 Trail prism on badland area.

However, if use is reduced trails on the southern side (Cirque 2) may “self-heal” as rapid side slough covers the tread. Trail markers and frequent enforcement may also reduce impacts.

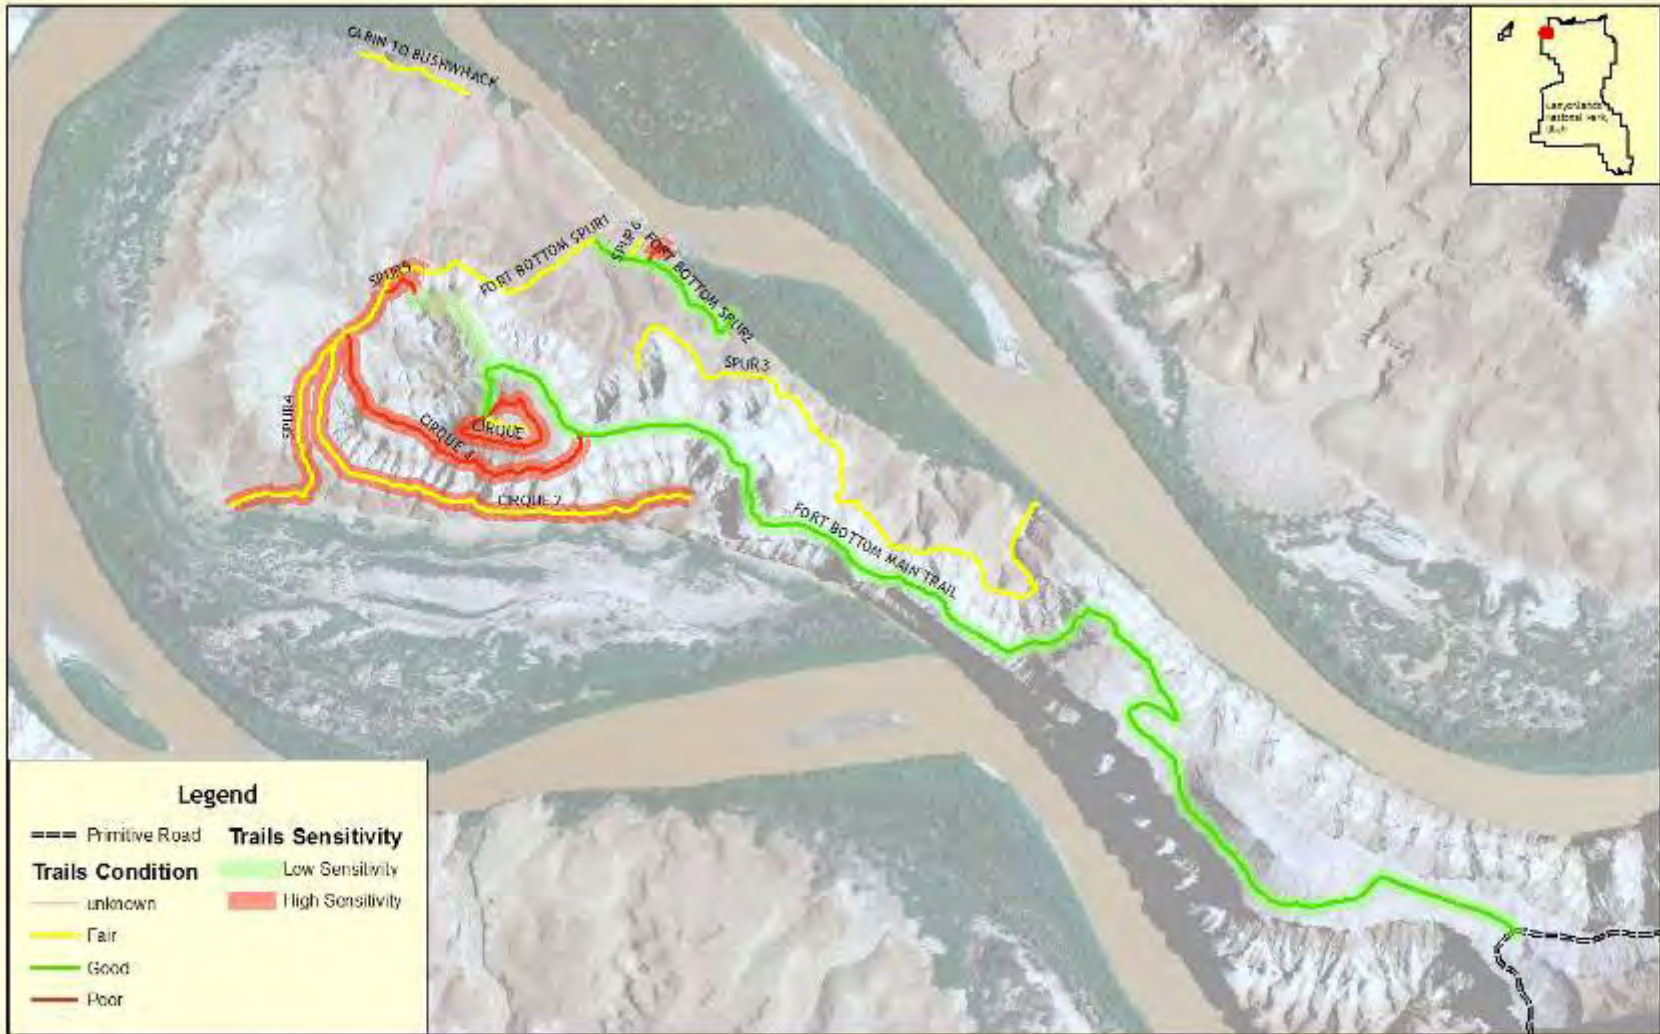
Figure 4. Trail Condition and Sensitivity for Fort Bottom Trail

The Fort Bottom Main Trail is generally in good shape (low erosion, tread is stable, little trail widening) and is also in less sensitive material (primarily sandstone with some siltstone). It was apparently an old 4WD road which has been converted to a trail. It has rock borders in places and waterbars on steep slopes. Though it appears to be located on steep slopes (Figure 5), it actually stays primarily on a narrow, flat ridgetop, on sandstone. Where on steep sideslopes, the trail follows an excavated 4WD road. This road is significantly eroded, but the trail itself has been stabilized with waterbars.

Cirque 3 and Cirque trails both are rated as being in “Poor” condition, as well as being highly sensitive. They are both on very steep slopes, and are in the erodible Moenkapi formation (Figure5, 6).

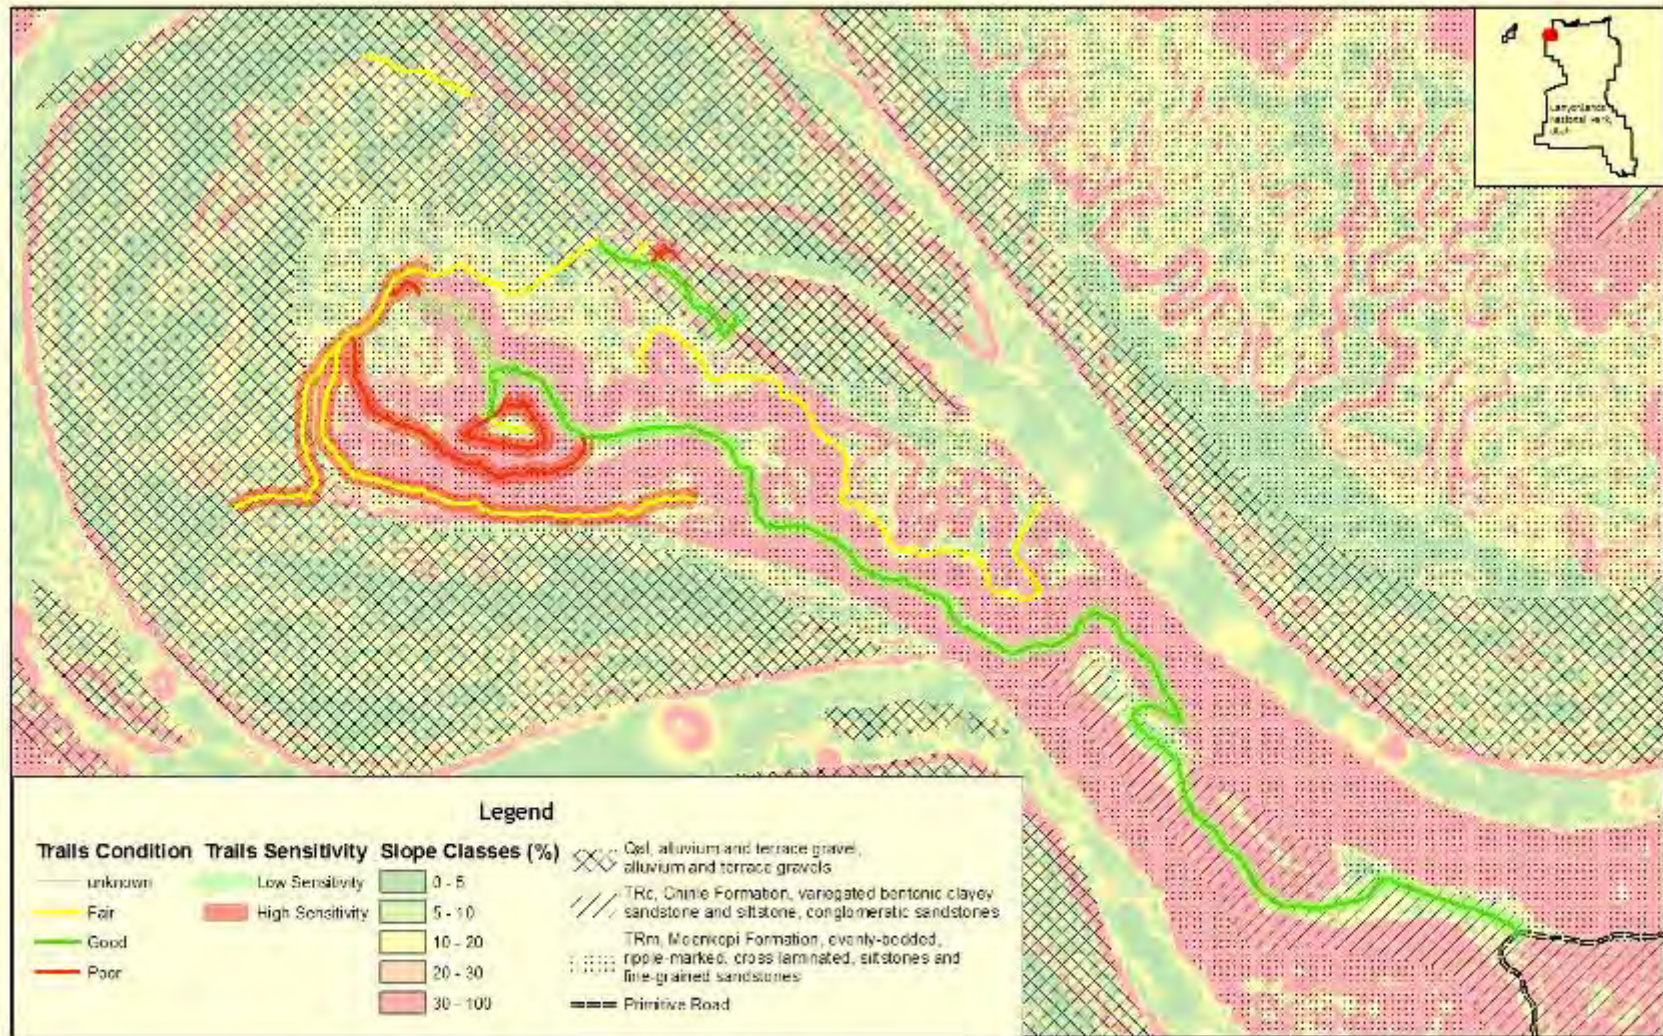
Figure 5. Geology, Slope, and Trails in the Fort Bottom Area

The lower trails (Cabin to Bushwhack, Spur6, and Fort Bottom Spur2) appear to be relatively stable, since they are located in alluvium rather than on the Moenkopi formation (Figure 5). However, Fort Bottom Spur1 goes through a transition zone between the two geologic types, and is probably eroded on sloping segments. It is of lower sensitivity than the trails near Spur4. One un-named spur near Spur5, however, appears to climb steeply from the river, and is in “Poor” condition.

Soil conditions identified in this field review compared with the San Juan Soil Survey show that the Survey is not very accurate in this area. Trail limitations presented in the Survey are probably too conservative, and do not reflect the actual character of the area. Geology and Slope (Figure 5) offer a better correlation with condition/sensitivity. Trails in the Moenkopi formation and on slopes greater than 10% appear to have higher sensitivity and poorer condition.

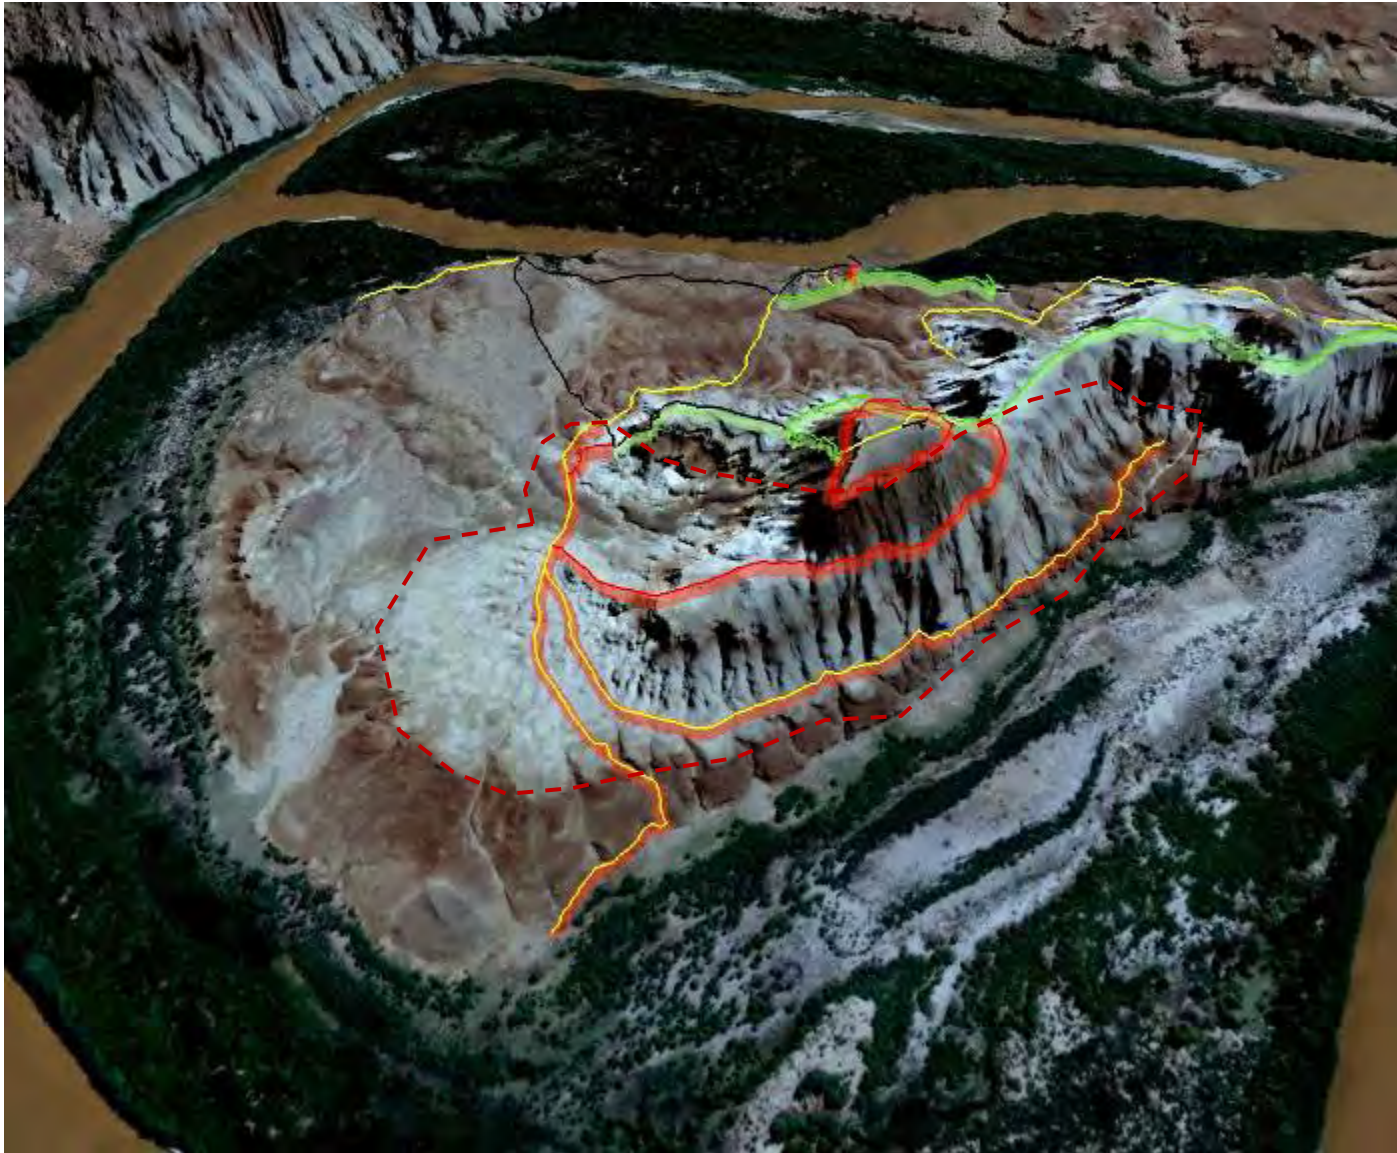
Figure 6. Perspective view of the Fort Bottom Trail (highly erodible area in the red-dashed polygon)

Based on this sample and the trail inventory, the steeper, erodible parts of the Moenkopi formation appear to have the highest hazards for resource protection and visitor safety. Figure 6 contains a dashed polygon which shows the approximate extent of the area.

If the management objective is to reduce resource impacts the use and creation of social trails should be discouraged. Because of the nature of the underlying soil, social trails on the north side are highly visible (Spur3 and Fort Bottom Spur1). On steeper slopes social trails can be hazardous, and contribute to destruction of bio crust as visitors wander looking for the trail prism or slip off the tread.

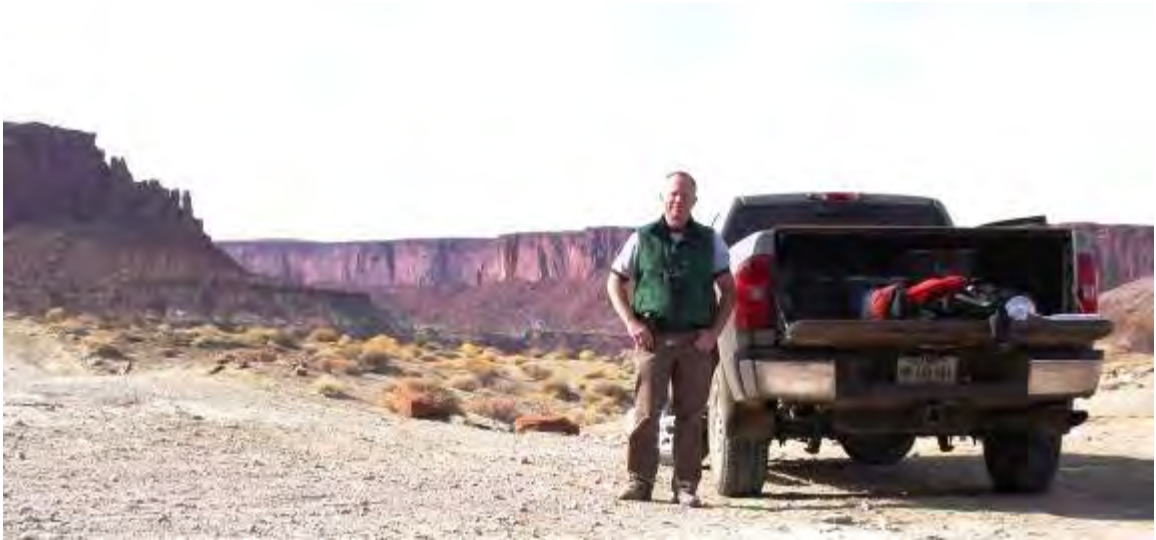
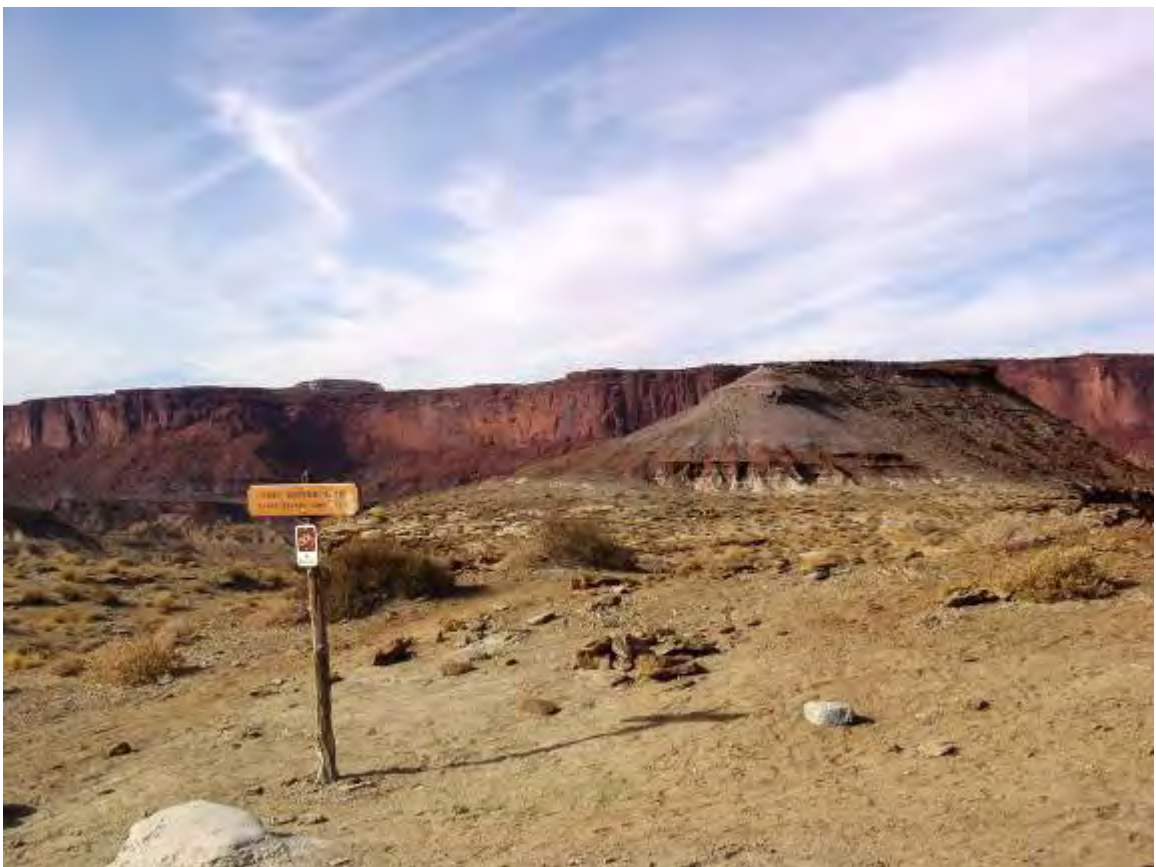
WP 1 is the beginning of the trail. Pictures 188, 189

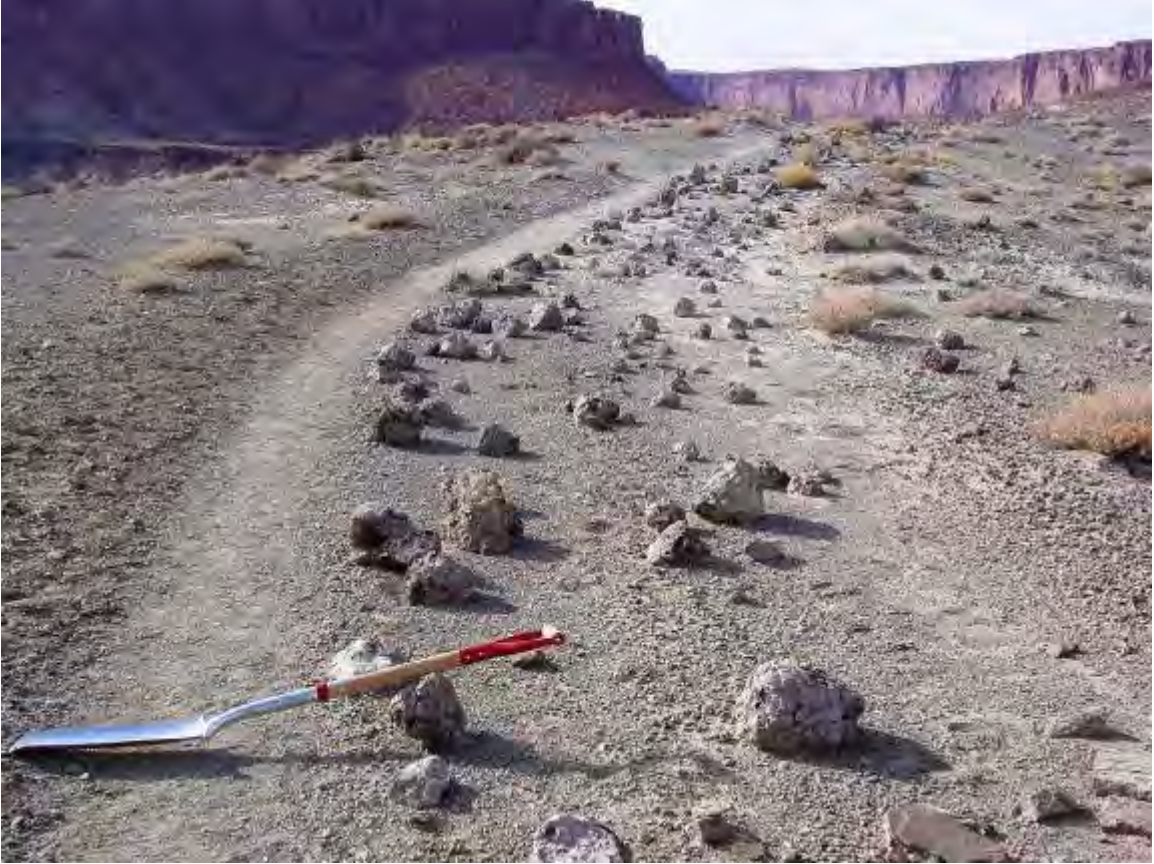
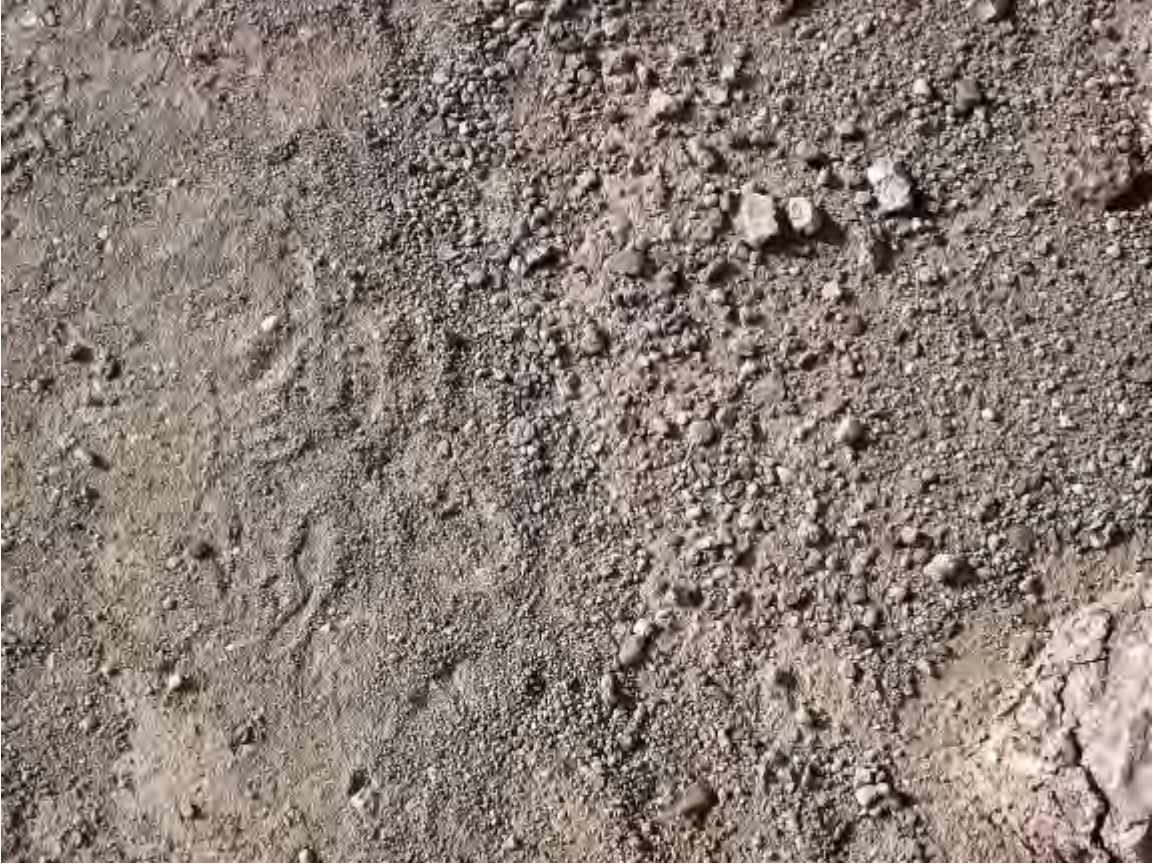
Between WP 1 and 2, pictures 190, 191 in shale

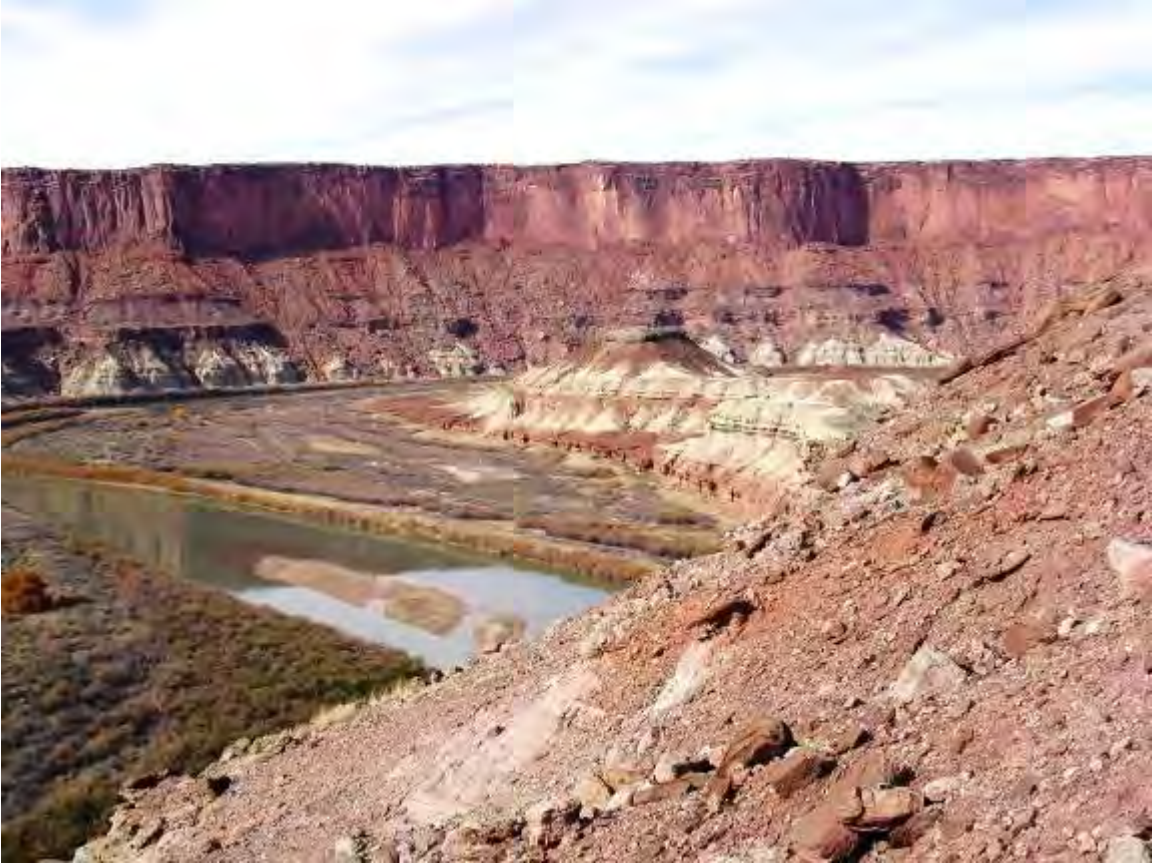
WP 2 Panoramic picture 192

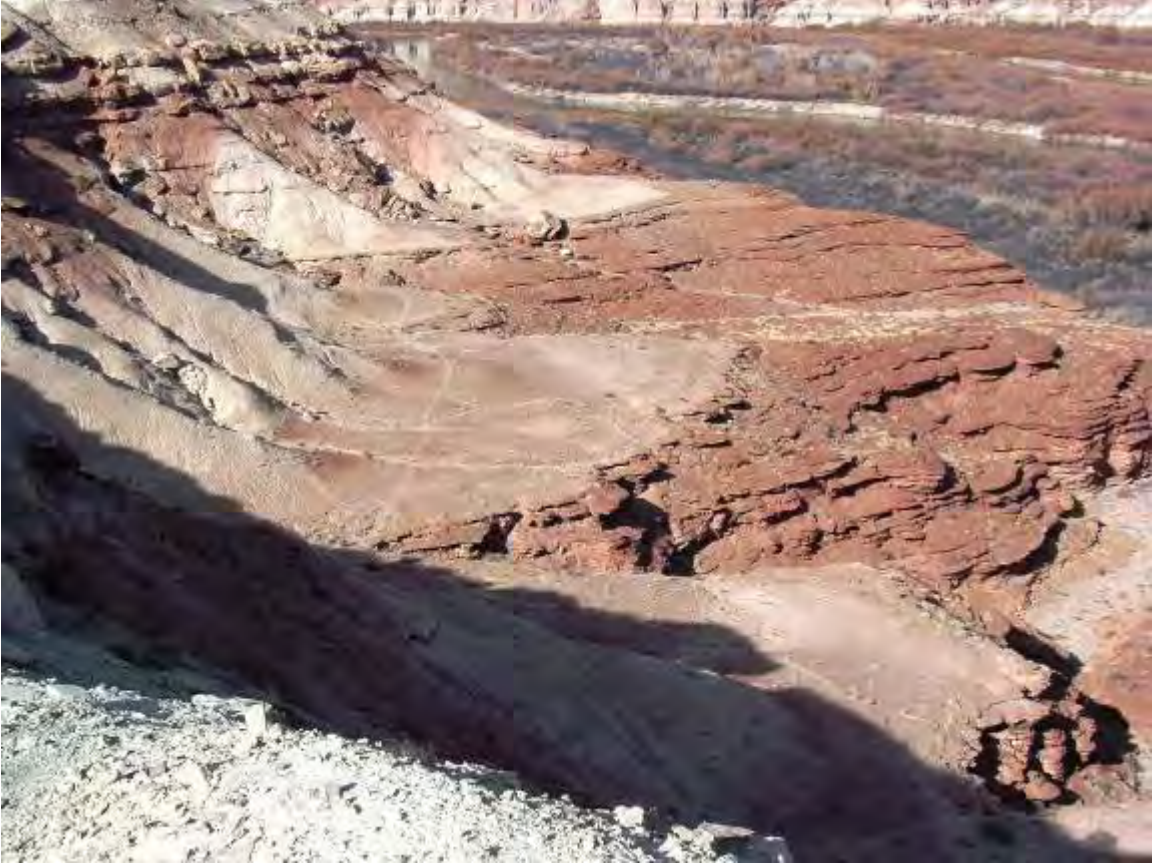
WP 4 looking down at social trail Pic 193

Shows trail in crumbly shale – highly visible, but little erosion evident.

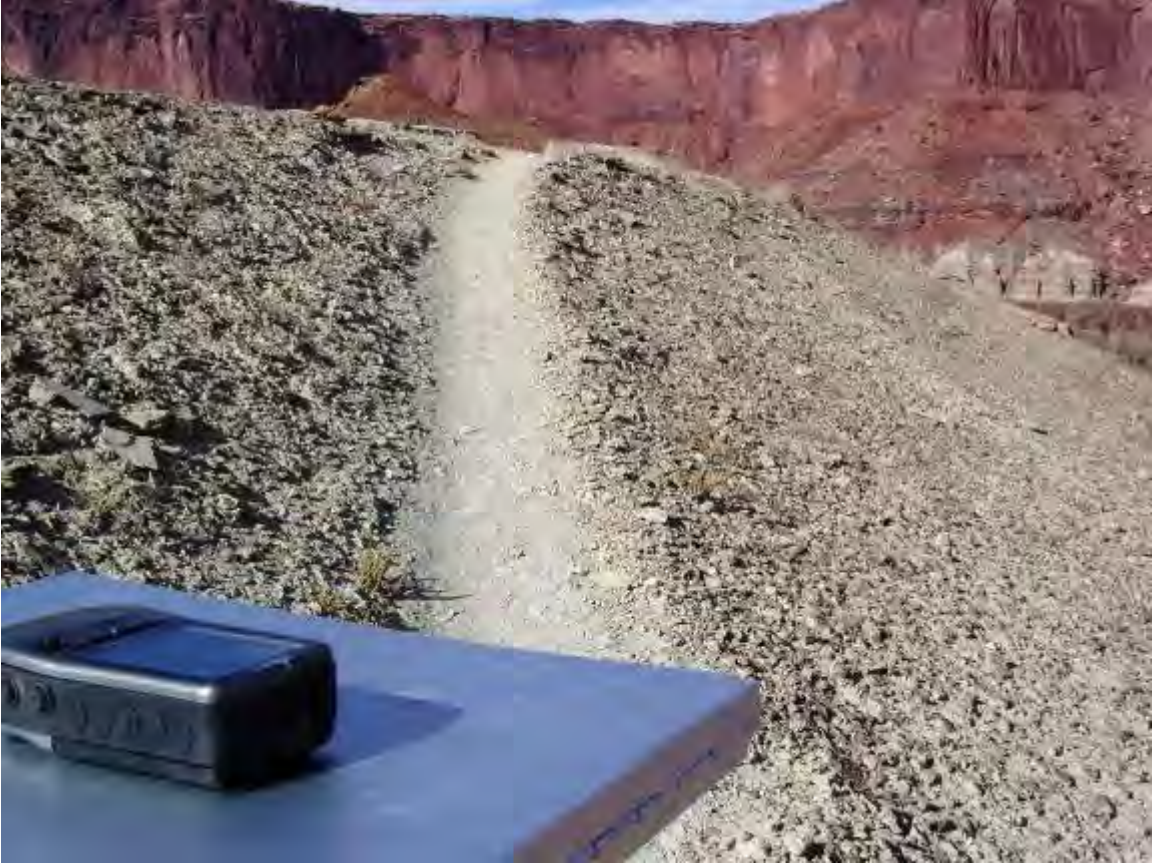
WP 5 trail east of 5 that shows rated “unknown” on the map is good shape, eroded 2 inches on sandstone/shale; pic 194 shows a representative segment
