Project Report: Canyon Lands Fort Bottom Trails  
Field Review, Analysis, Conclusions, and Recommendations  
Henry Shovic, PhD  
Rocky Mountain Cooperative Ecosystems Study Unit  
Mar 4, 2009

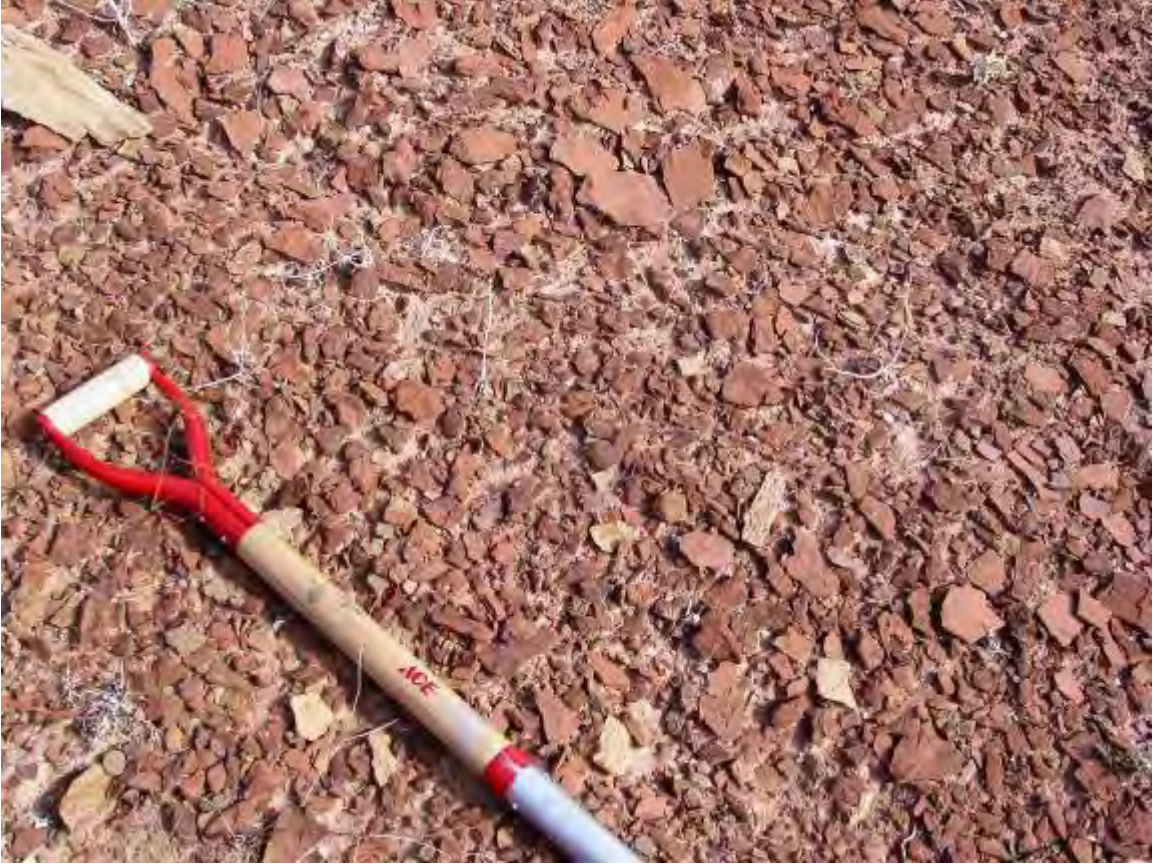
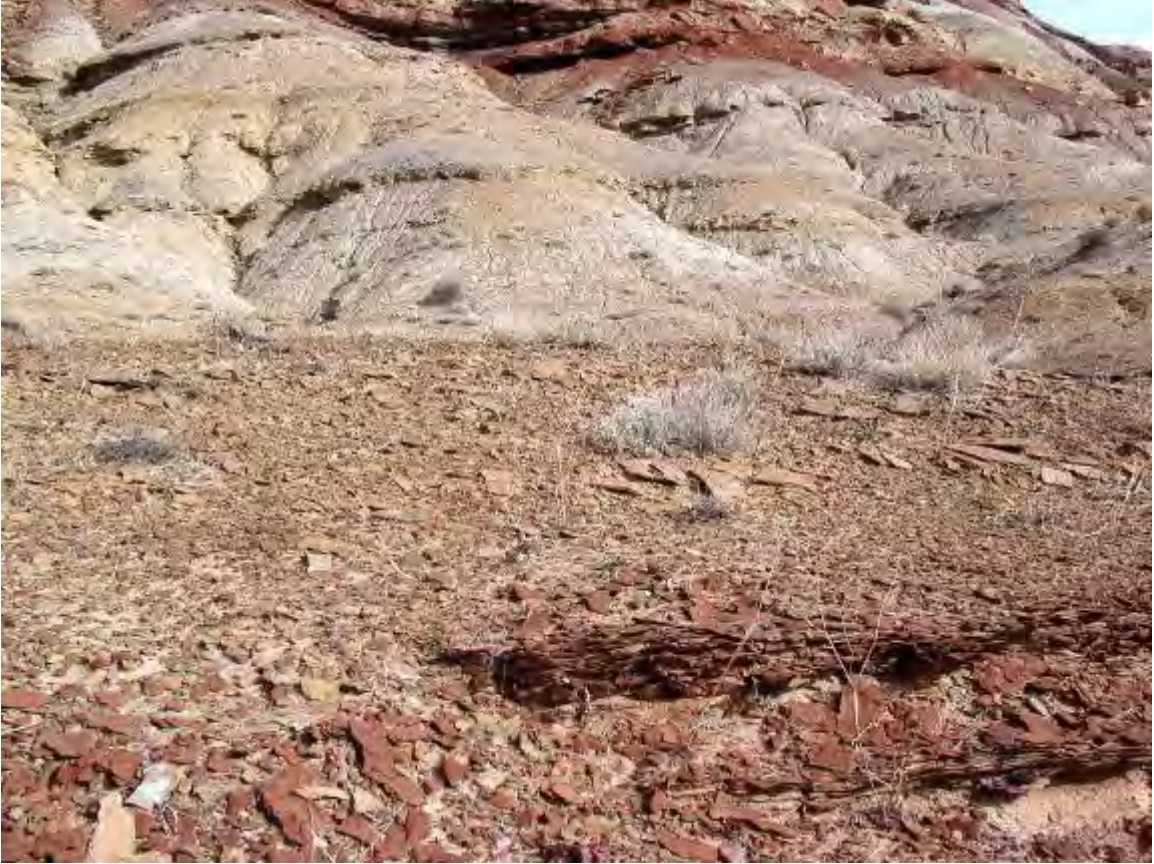
WP 9 desert pavement, pic 195, 196 fragile area, friable sandstone over erodible weathered shale. Soils are silty with some fine sand.

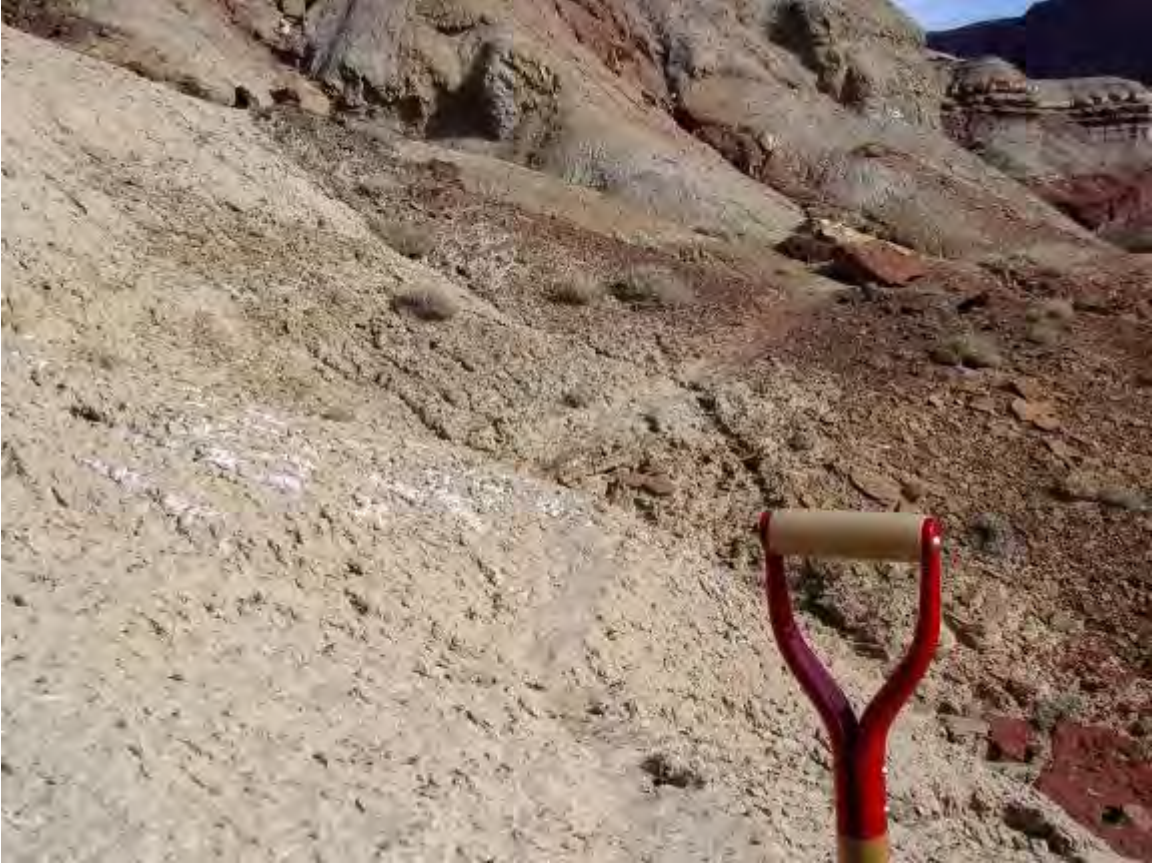
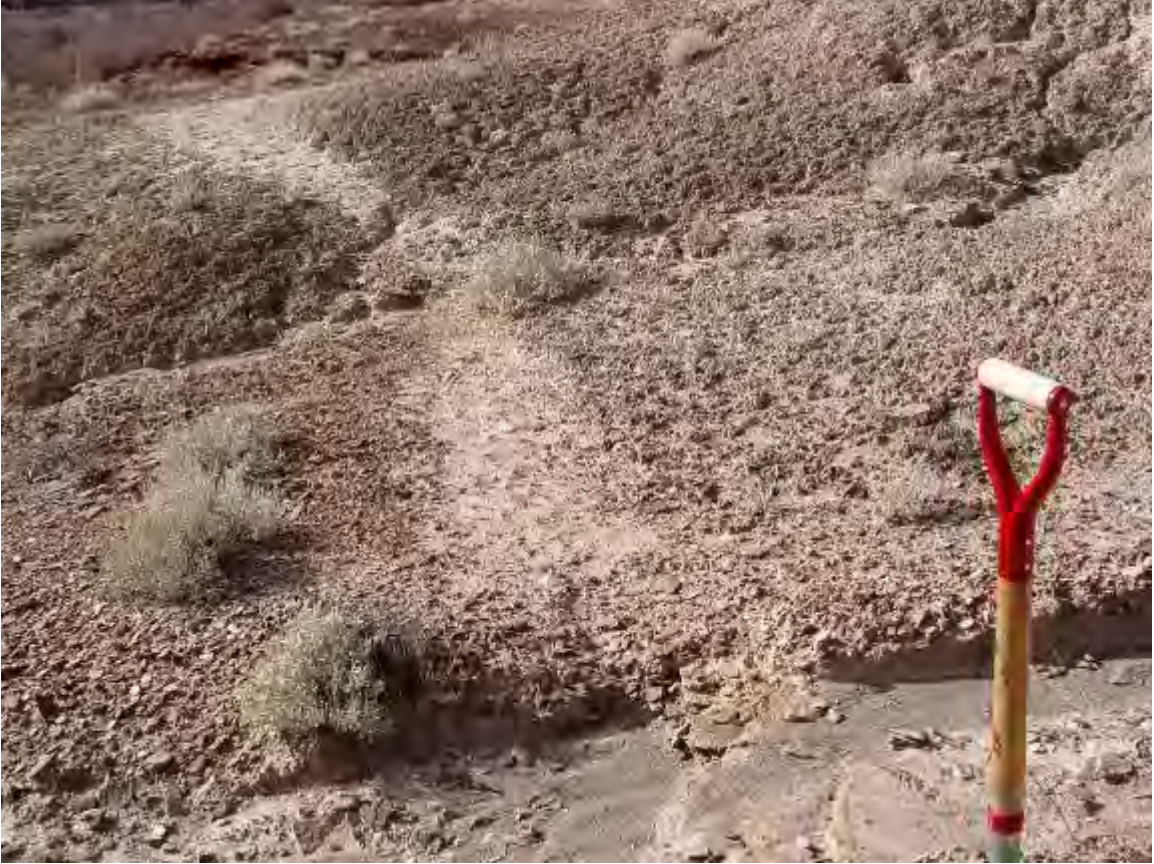
WP 10 soil is silty with desert pavement, except for trail tread; very silty weathered shale; pics 197, 198

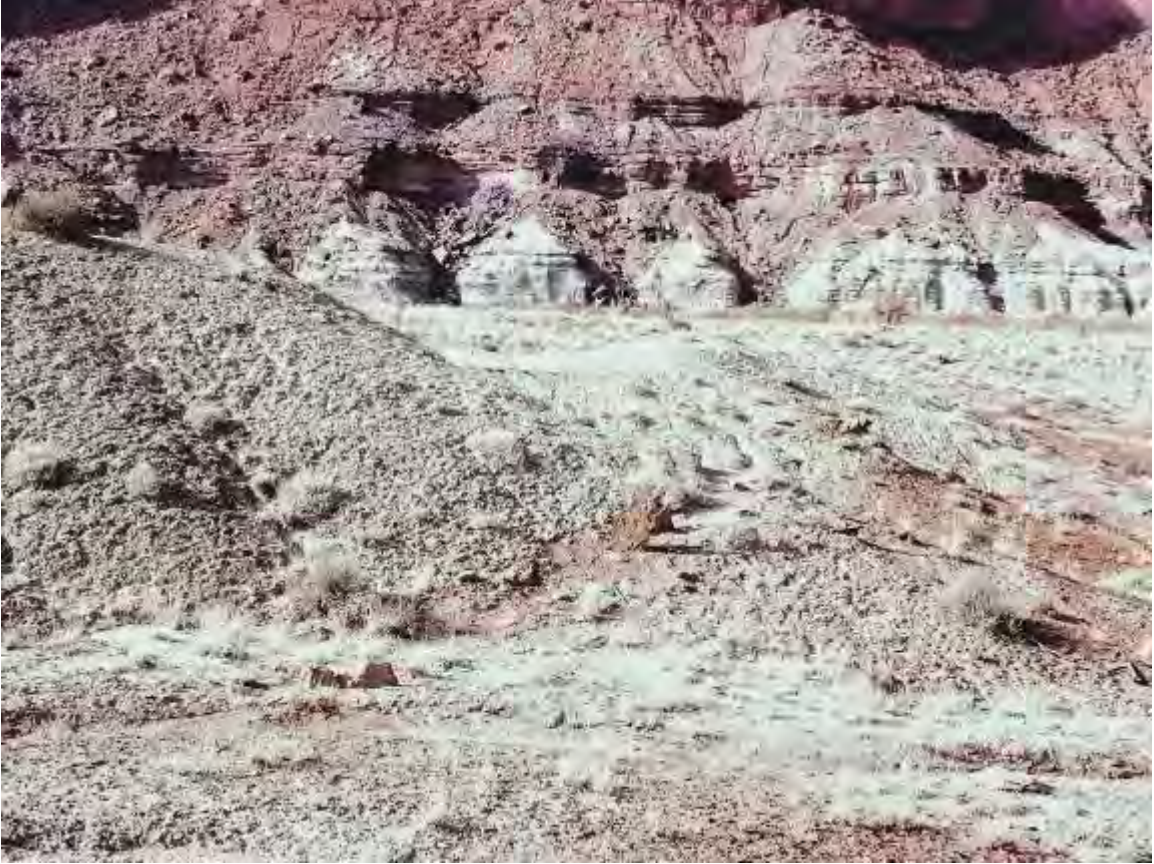
WP 11 end of social trail with a small barrier; at least three social trails lead away from here. Pic 199

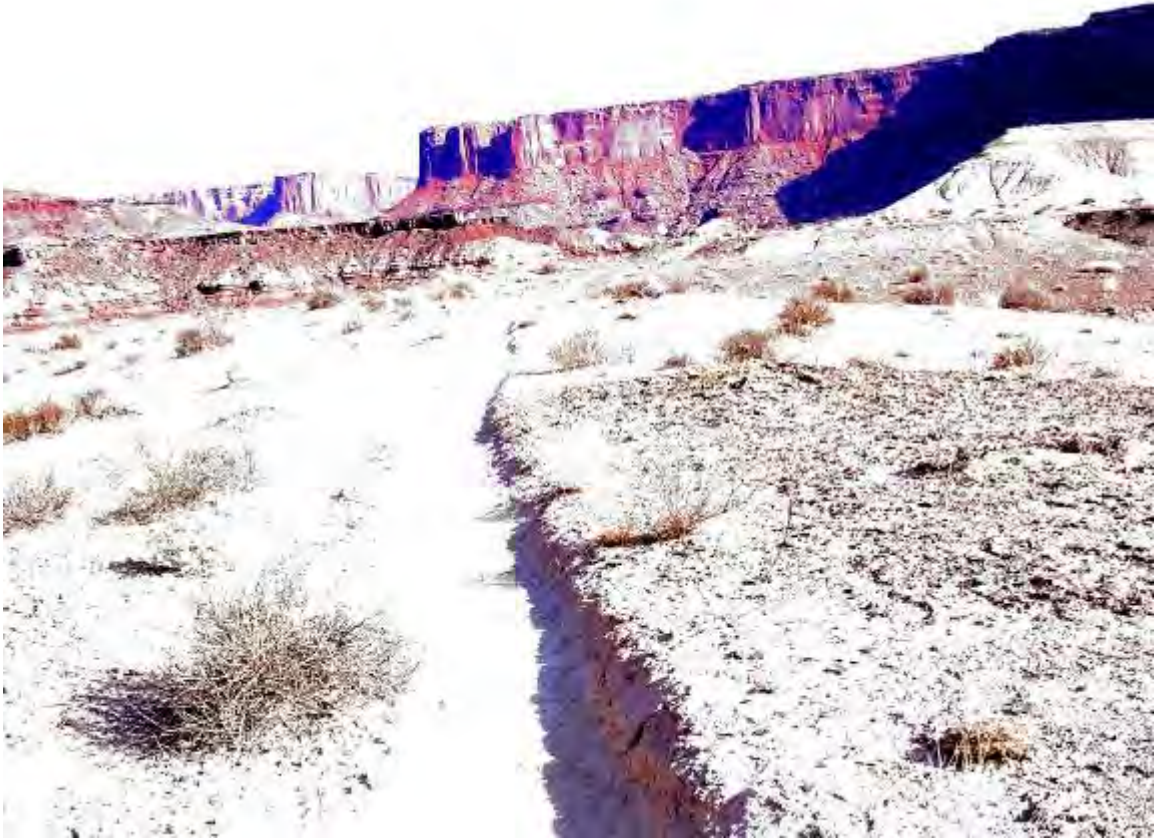
At WP 11 continuation of social trail, but well maintained, and a series of rocks have been placed to keep people on the trail. Eroded up to 6 inches, but now relatively stable; Pic 200

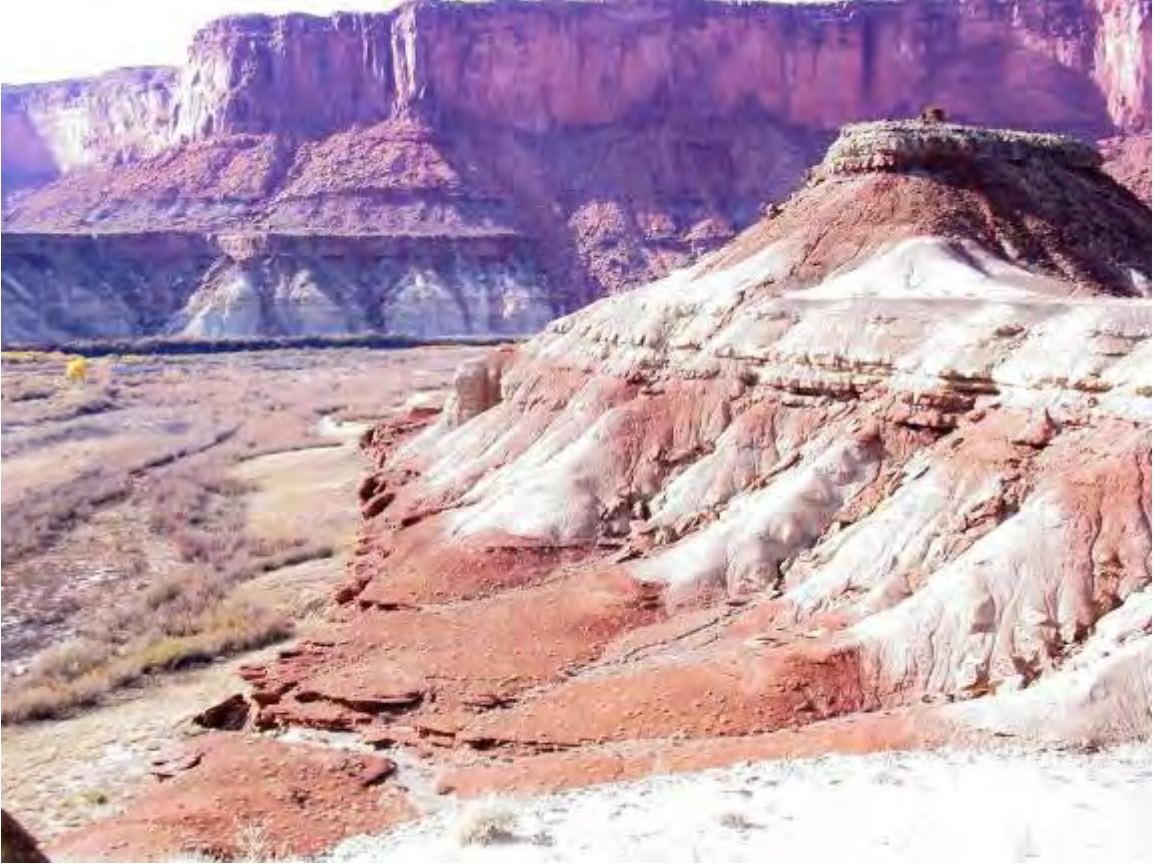
Picture looking back at the red-rated trail near WP 12; close to WP 4; pic 201 Hard to see tread, because highly erosive soils have covered it.; self recovering; no recent use this year; possibly should be barricaded or signed.
