Project Report: Canyon Lands Salt Creek Road
Field Review, Analysis, Conclusions, and Recommendations
Henry Shovic, PhD
Rocky Mountain Cooperative Ecosystems Study Unit
May 3, 2009

This document addresses Objective Two in the agreement “to provide alternative development analysis and support” for three project areas as designated by NPS staff. This report focuses on the Canyonlands Salt Creek road.

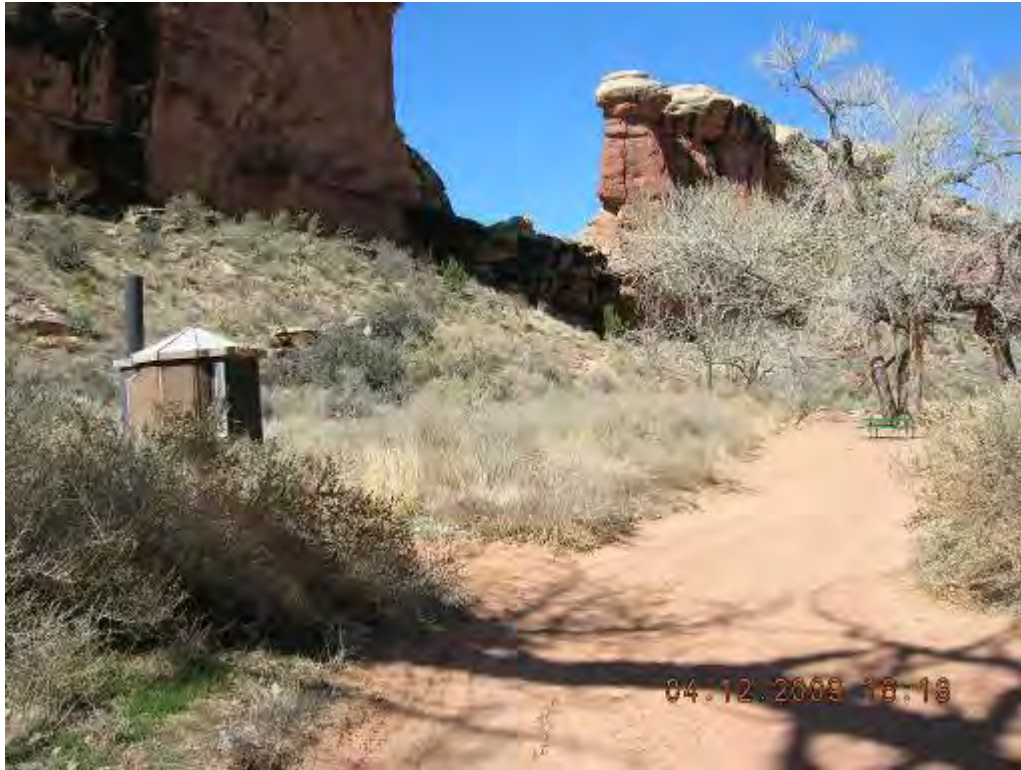
Soil materials in the vicinity of the stream are primarily alluvium and wind-deposited sand, modified by floodwaters (Appendix One). All soils are extremely sandy with occasional cobble or gravel layers. These kinds of soils have low productivity and fertility, and low resistance to erosion.

Sandy soils at Peekaboo Campground

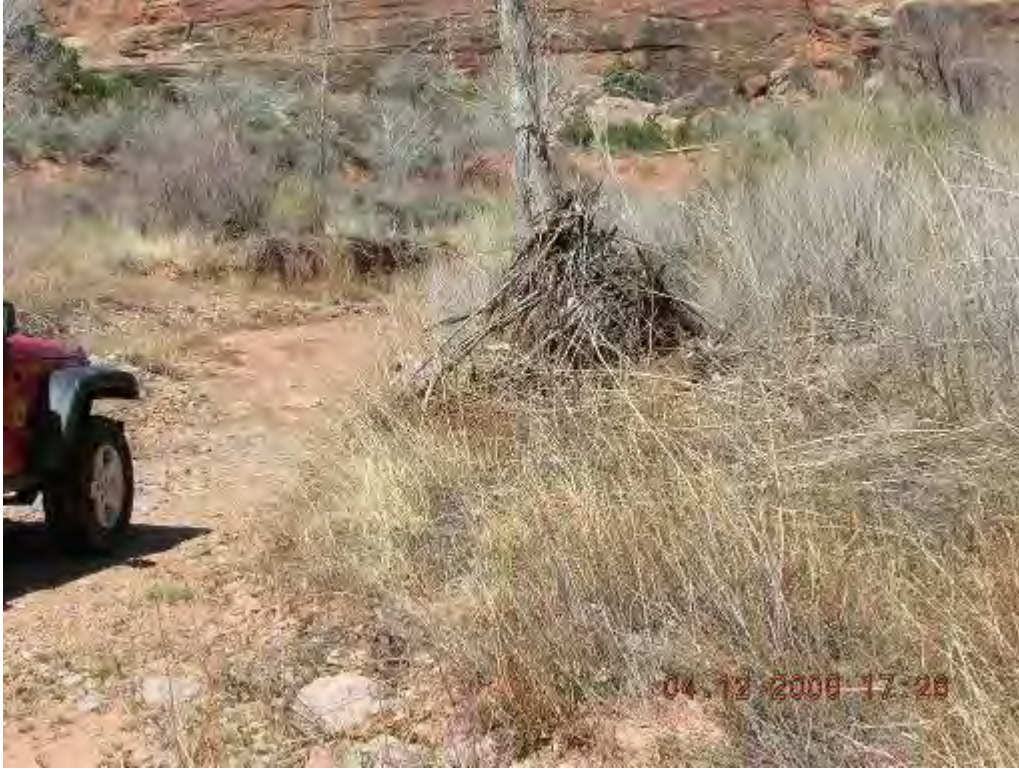
Evidence of flooding below the campground in Salt Creek

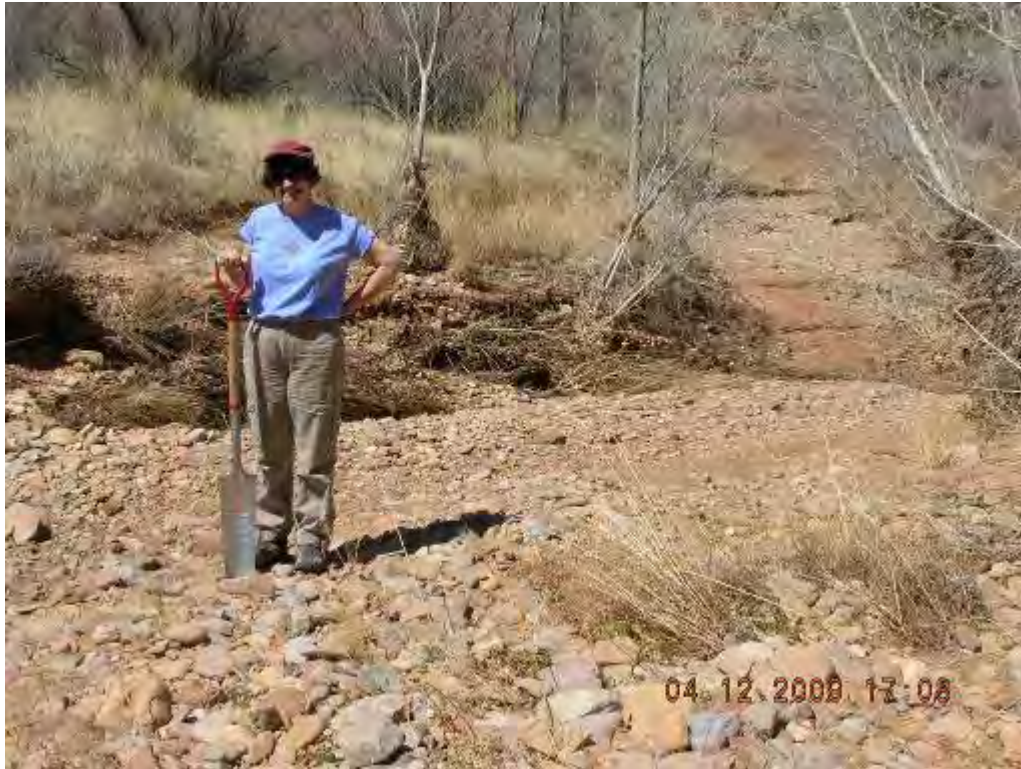
Gravel and cobble stream bed on upper channel

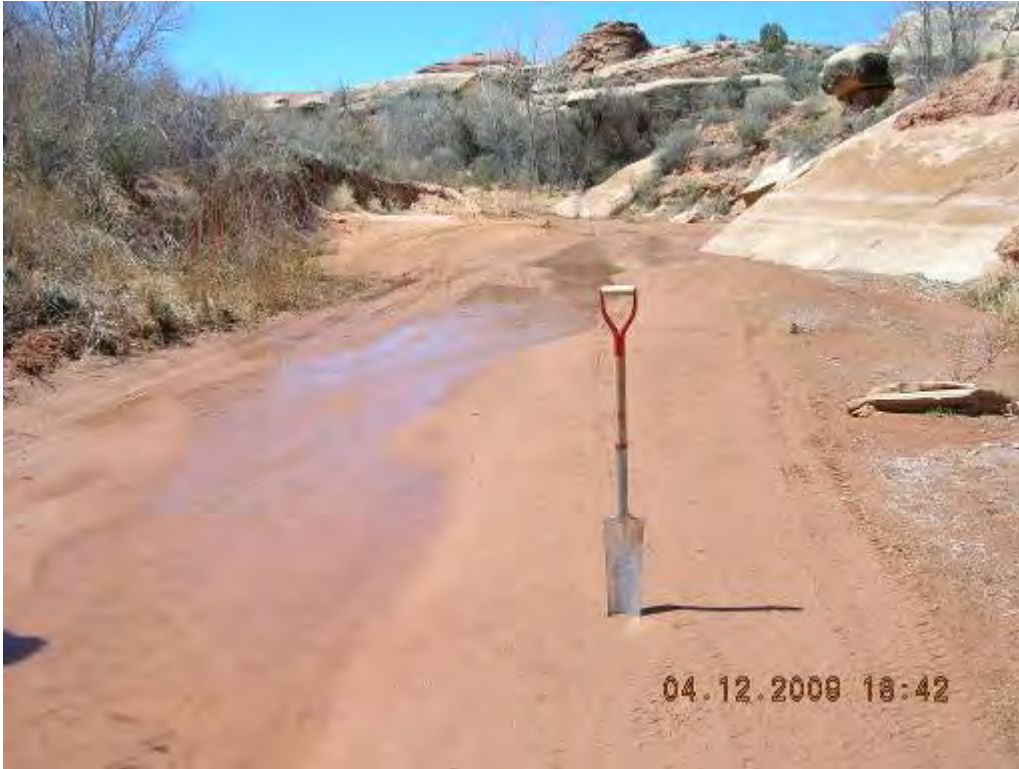
Sandy stream bed midway on lower channel

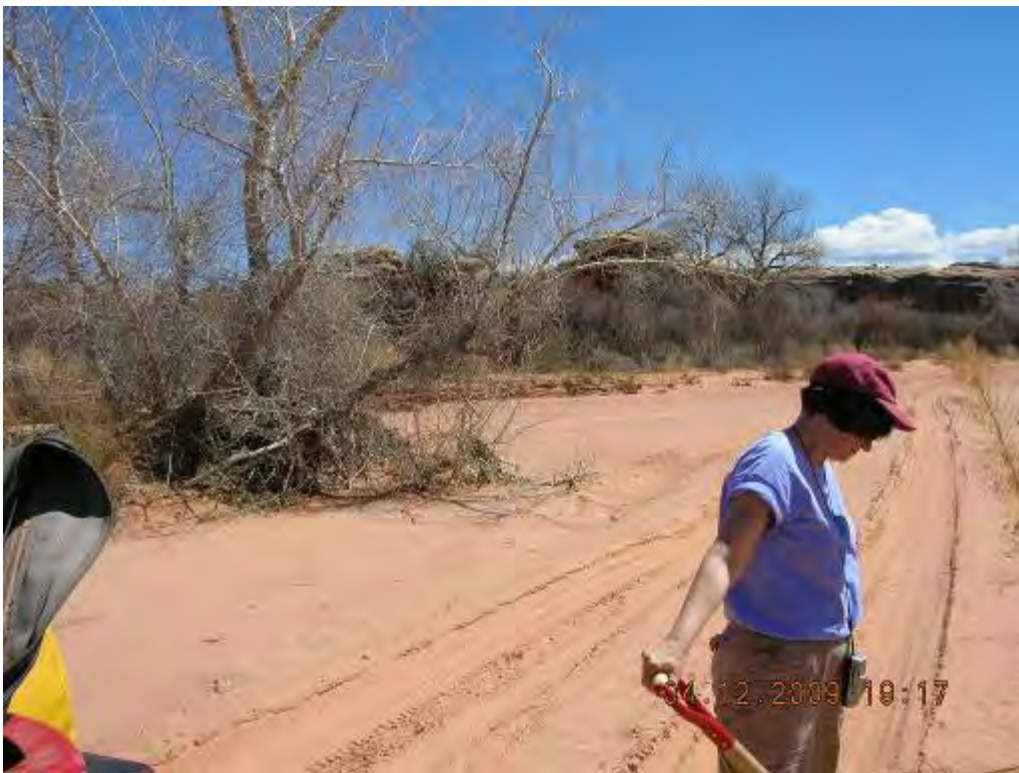
Sandy, poorly-defined stream bed on the lower channel.

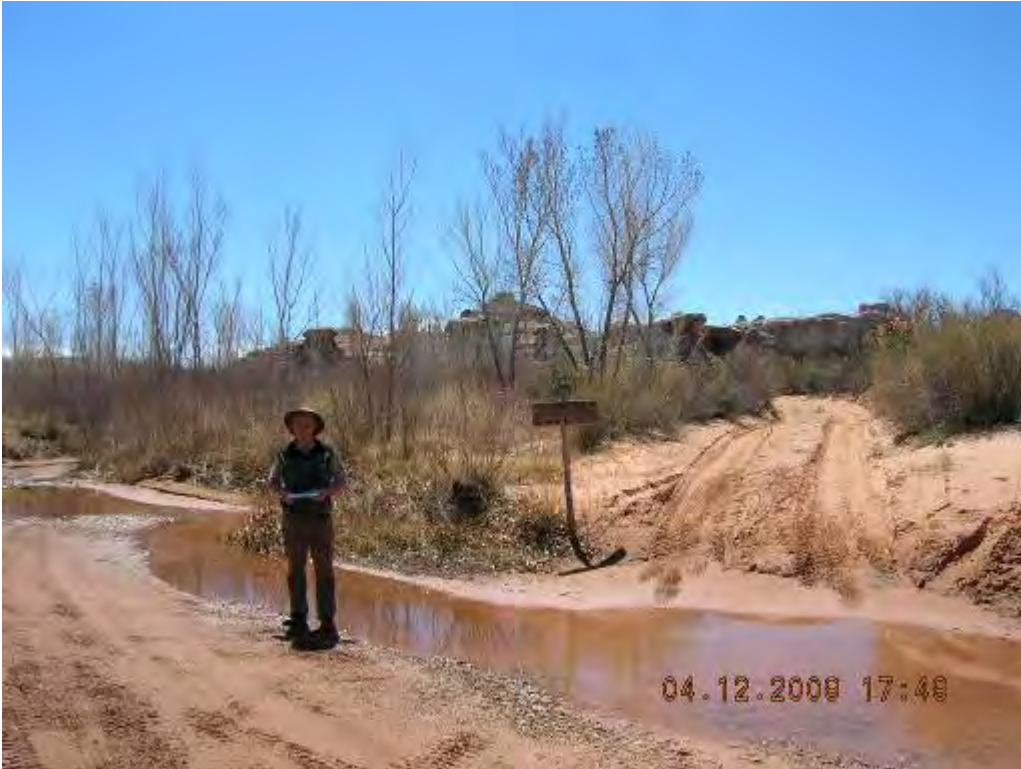
- The Low Terrace (represented by Point 49) is about five feet above the Floodway. This terrace shows evidence of occasional flooding and has a very sandy substrate.

Low Terrace

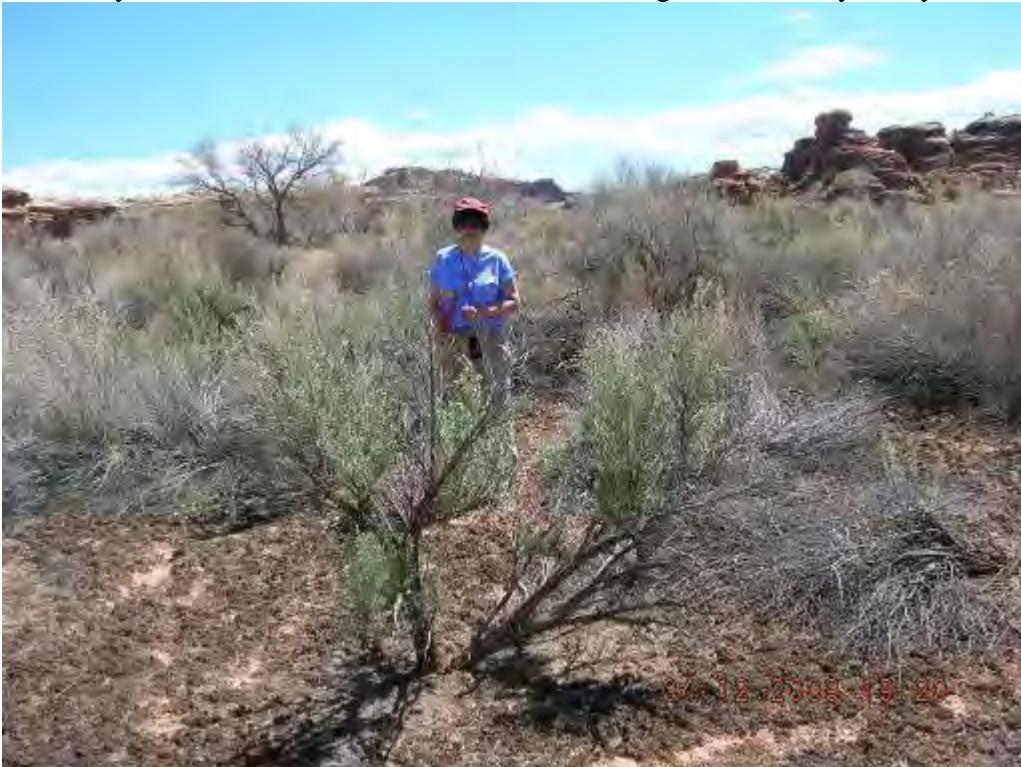
- The High Terrace (represented by Point 55 and 60) is about eight to thirty feet above the Floodway and shows no evidence of recent flooding. It has a very sandy substrate.

High Terrace

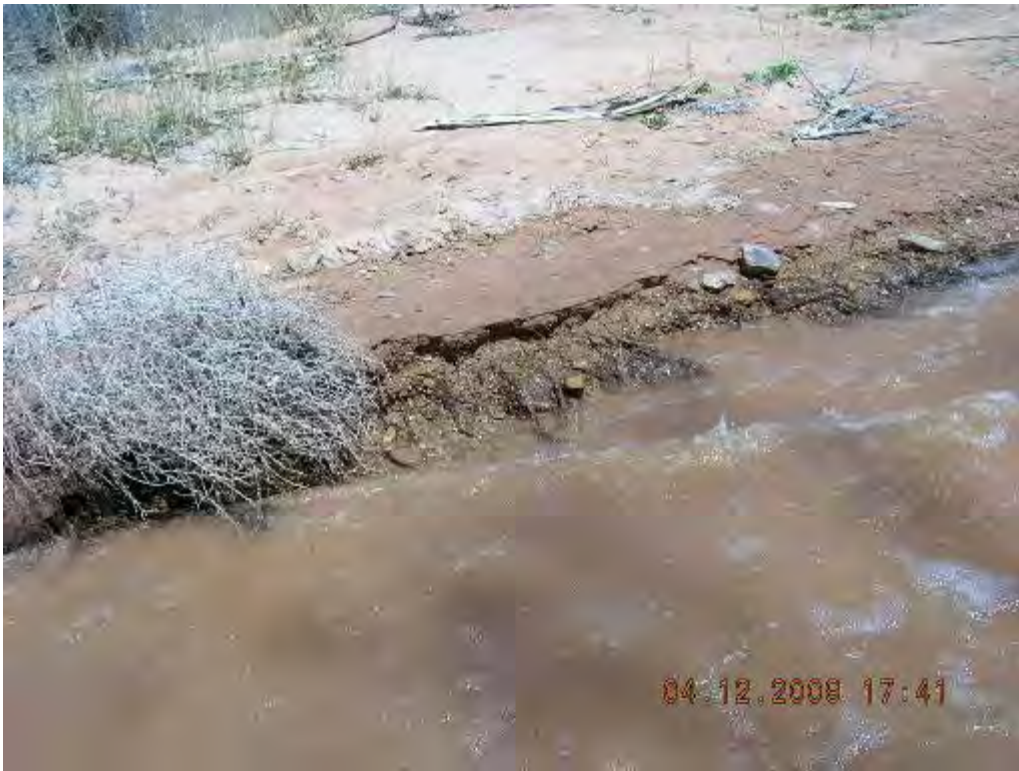
Vehicle impacts appear to be significant in the flowing part of the stream (Point 23 to 57). Disturbance is significant from even a very slow traverse (less than 1 mph), with apparent erosion of side banks, exposure of roots, and turbidity. These are all probably detrimental to bank vegetation and invertebrate health.

Erosion, turbidity, and root exposure from low velocity vehicle traverse

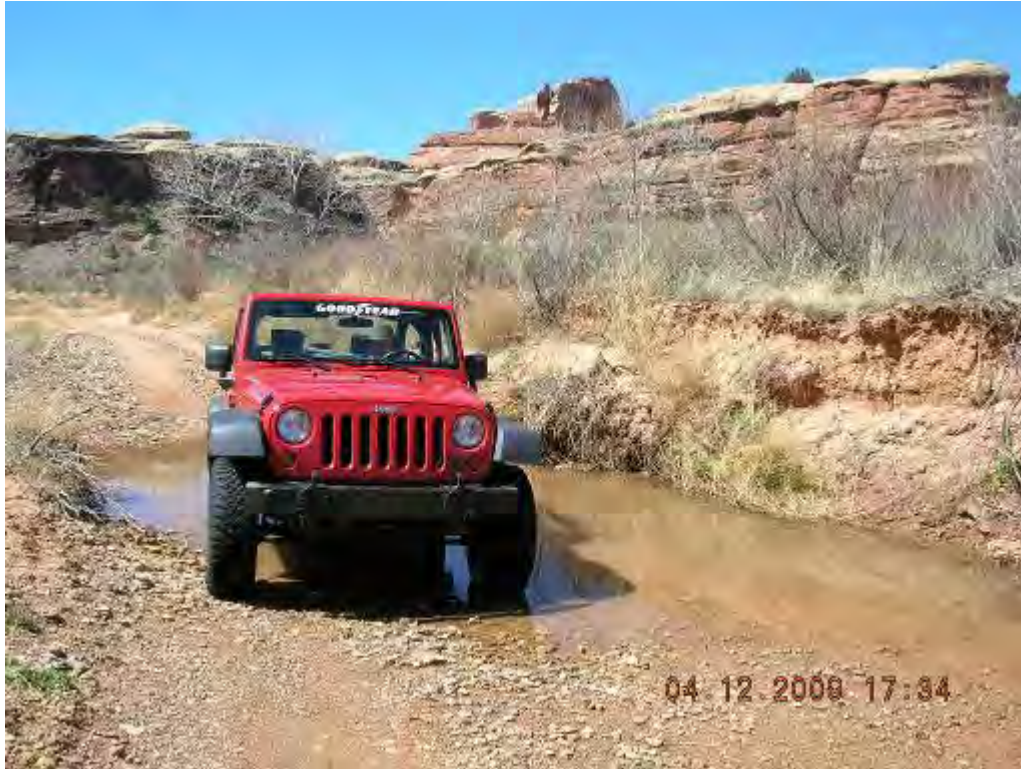
Large holes occur in the active channel. These are apparently related to vehicle use, similar to the formation of potholes or washboards on other native surface roads. These holes can be large enough to affect stream flow (Point 40).

Pothole probably caused by repeated vehicle traverse

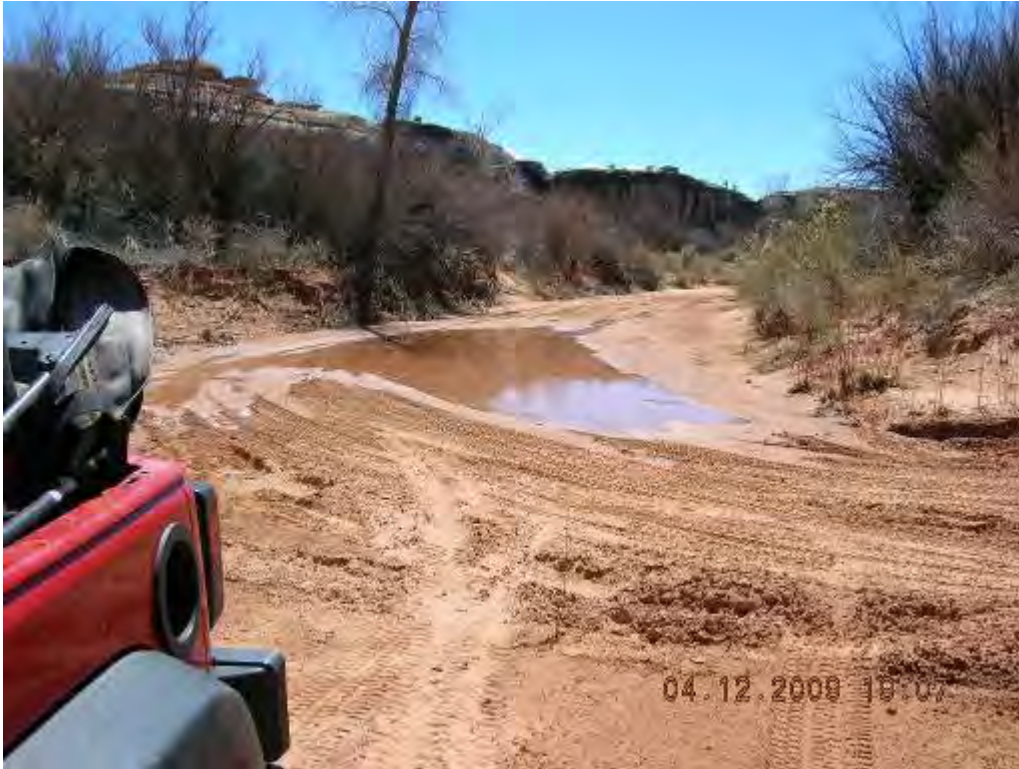
Stream channel characteristics appear to be different in areas without the impacts of vehicle traffic. At Point 56, a segment of stream channel shows no evidence of vehicle use. The channel is significantly different than the nearby road/channel. No large holes or unconnected pools occur in the un-driven area. In nearby stream channels with no apparent vehicle use, vegetation is present in the channel and it is less disrupted by large holes.

Stream character with vehicle use

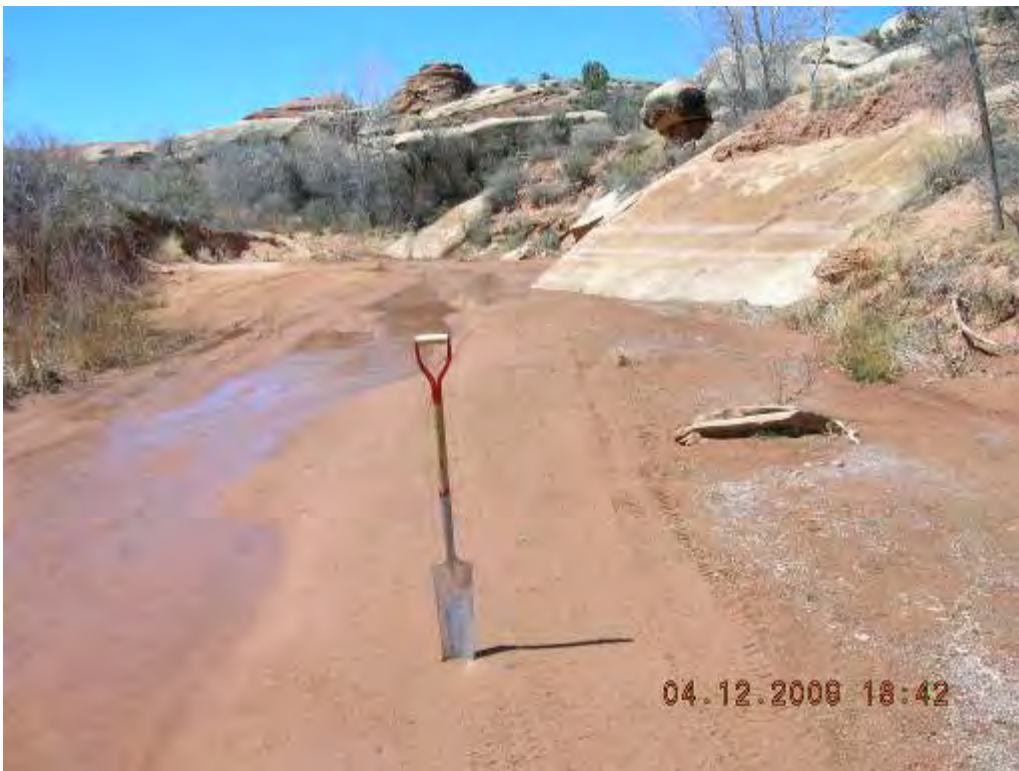
Stream character with vehicle use (bathtub ring area)

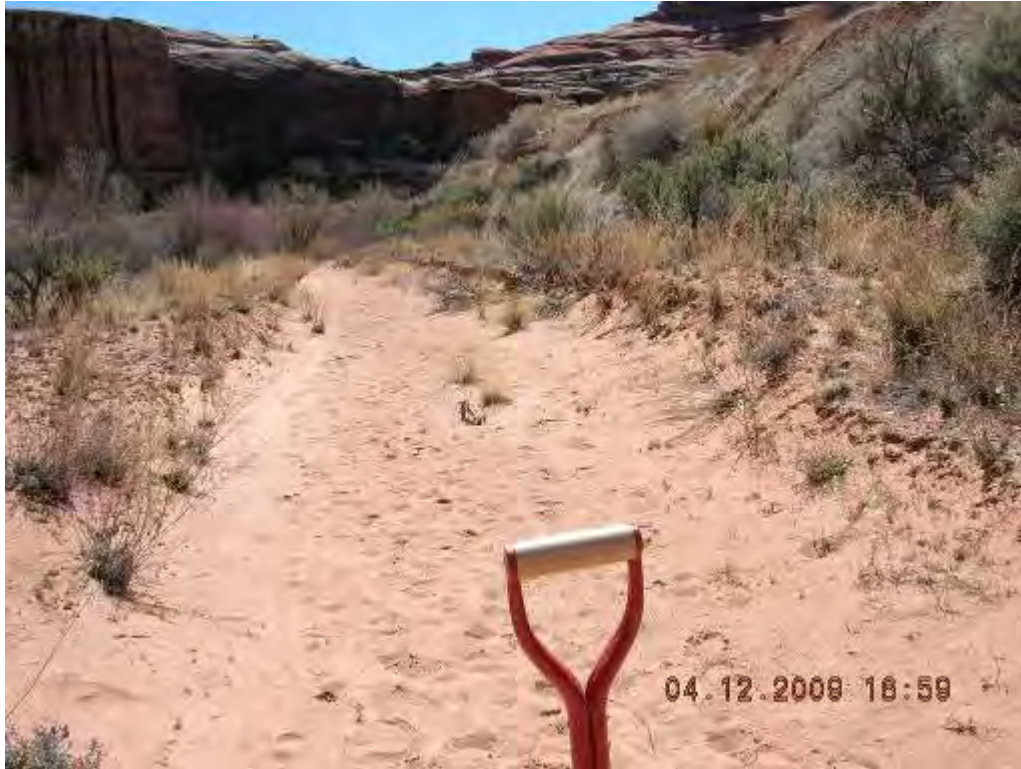
Removing vehicle traffic from channels or roads was observed to be enough to initiate vegetative recovery. At Point 20, past the gate closure, cut banks are sloughing towards a stable slope. At Point 21, an unused road has vegetation and incipient biological soil crust.

Natural sloughing and filling of unused road

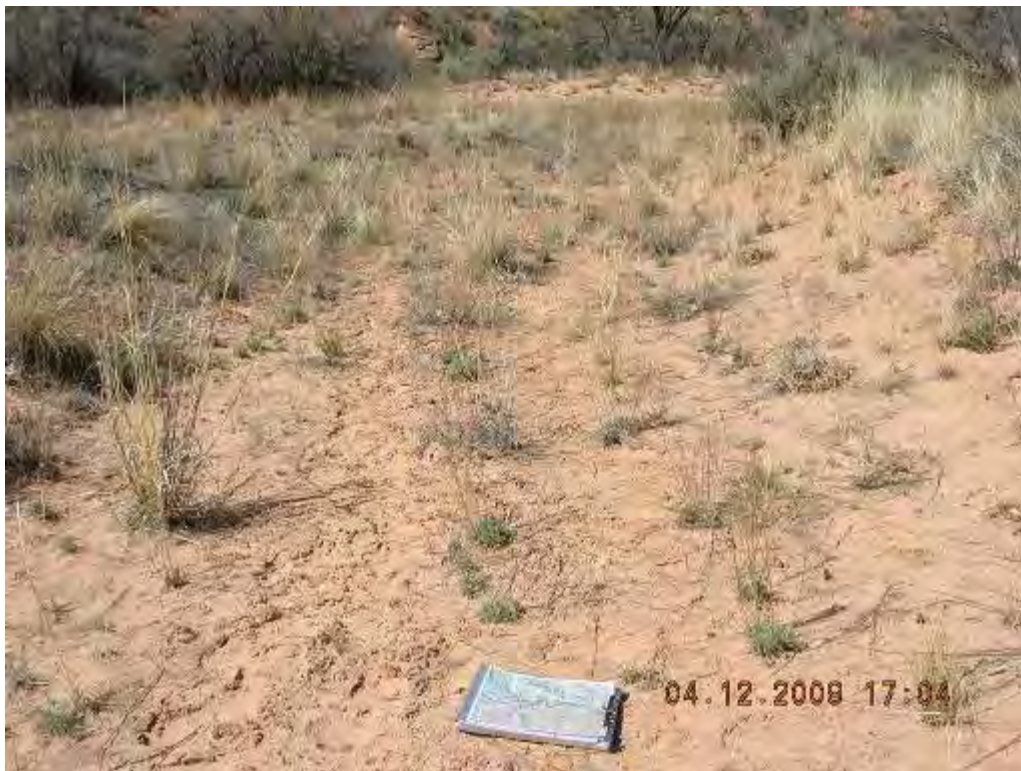
Natural revegetation and biologic soil crust formation on unused road

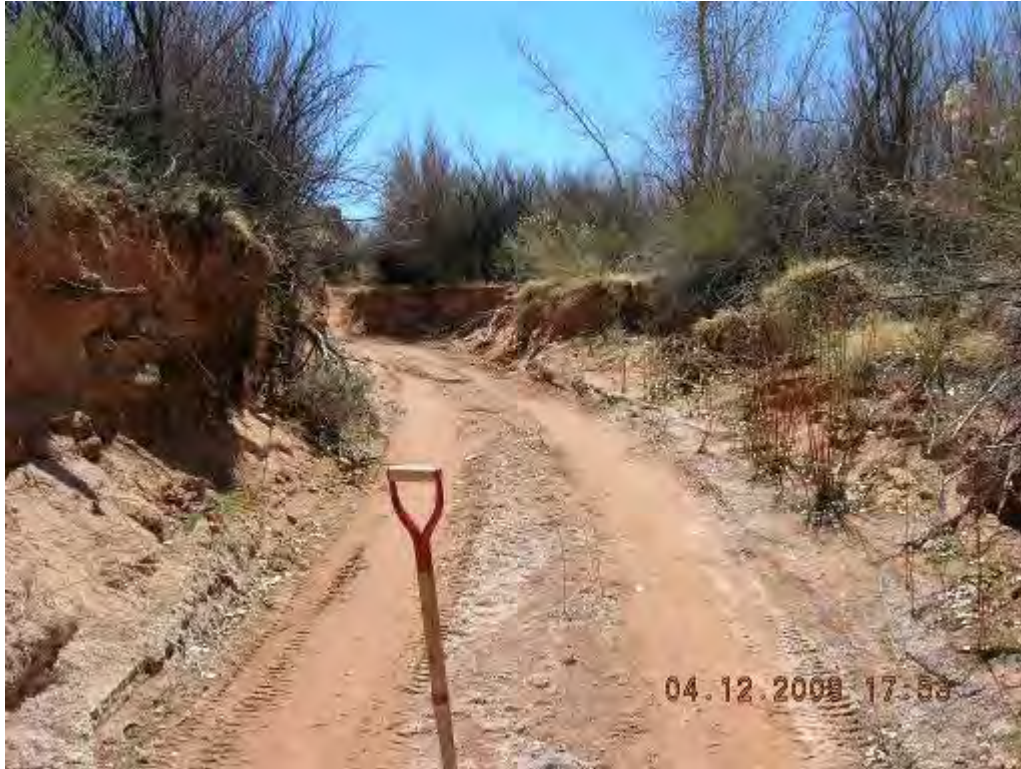
Horse Canyon road transects a series of steep banks (Point 44 to 46) in extremely sandy material. It has been eroded by vehicles and by intermittent stream flow down the road. Where slopes are gentle, little erosion has occurred.

Erosion on Horse Canyon road on steep sections

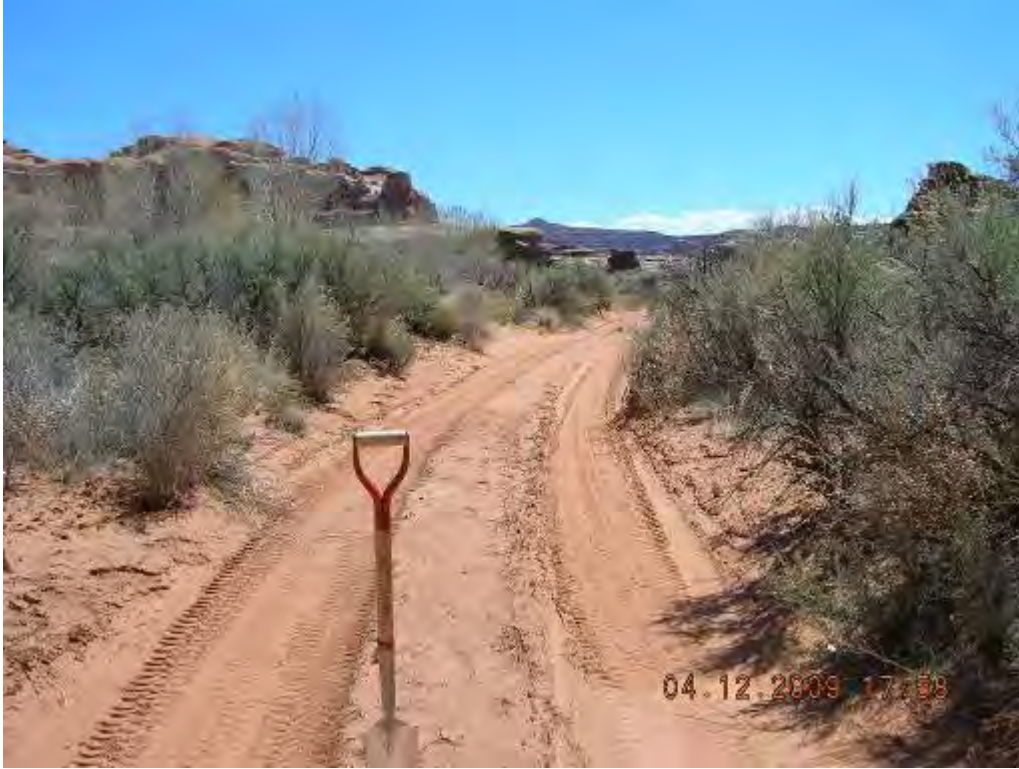
Erosion on Horse Canyon road on gently-sloping area

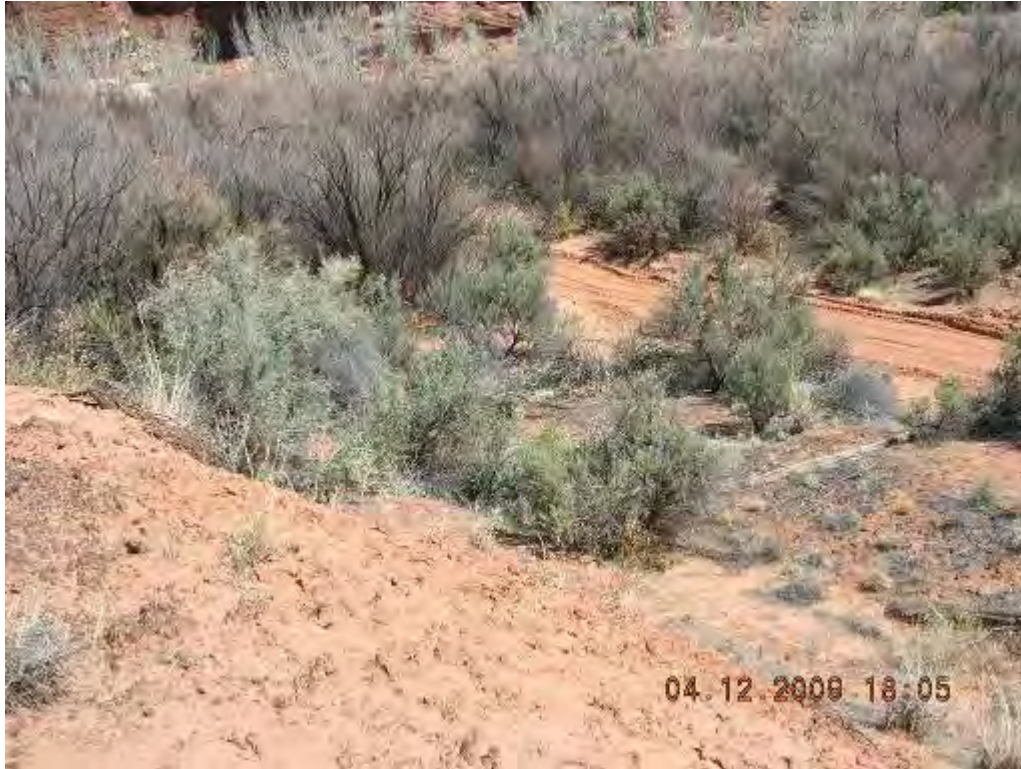
Two potential reroutes have been identified (blue and dashed red in Figure 3). Each appears to have potential to avoid the current road location, but both come very close to an observed cliff line, which probably extends south past the symbolized location on Figure 3, based on the aerial imagery. Both also appear to traverse steep sandy bluffs (slopes $> 30\%$).

Overview showing steep, sandy bluff and Horse Canyon road below

Therefore, both bedrock and steep, erosive slopes are likely to be potential problems for any road re-route through this area. Though it appears feasible, it will probably require engineering analysis and road mitigation measures such as surfacing, drainage structures, and grade control.
