Paktika Province, Afghanistan Water Resource Study:  
Watershed Characterization and Management  
Henry Shovic, PhD  
March 28, 2008

## 9.1 Introduction

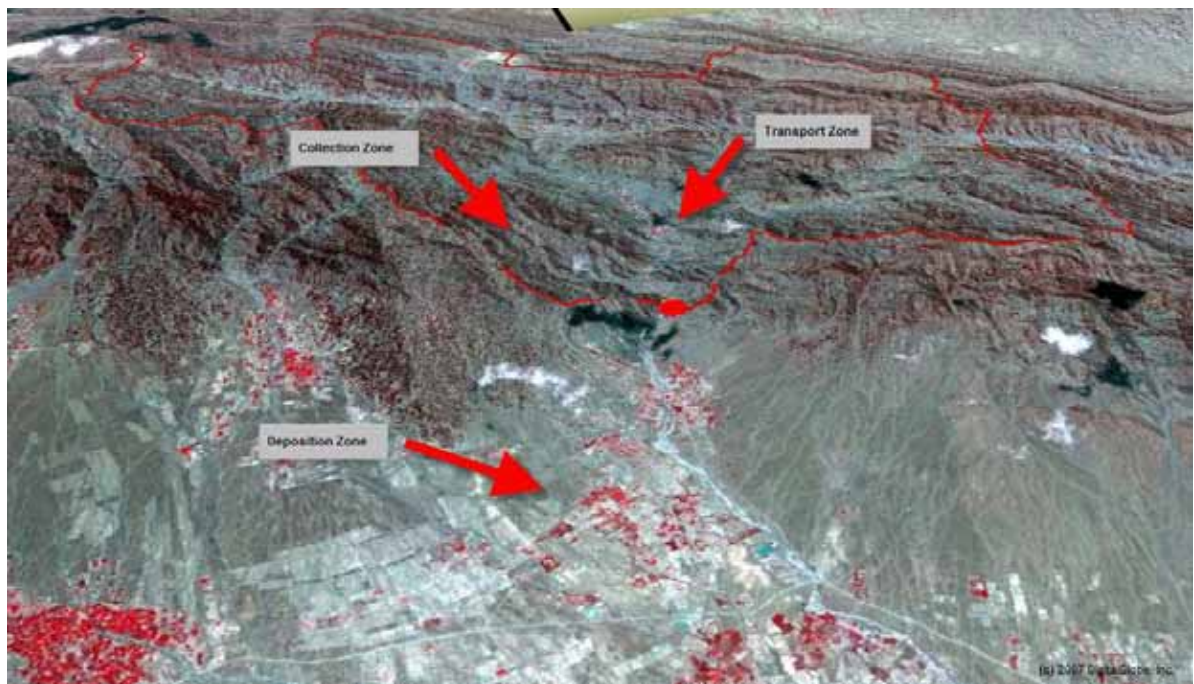
Figure 17. Zama Perspective Overview and Example of Watershed Zones

All candidate watersheds are in the collection and transport zones, whereas most of the present irrigated agriculture is in the depositional zone. (Figure 17). Many irrigation water supply problems in the depositional zone can be traced to higher zones, and this is the case here. Improving irrigation water supply in the depositional zone through pumps and wells, ponds, diversions and dams, spring development, and other methods must be accompanied by management of those upper zones, since the irrigation water supply is so heavily influenced by them. These upper zones have significant problems in terms of soil erosion, stream sedimentation, and management practices, as discussed below.

This broad scale soil survey has had little review, so there could be significant areas of better (or worse) soil included in these map units. Also, all these watersheds are in the collection and transport zones for irrigation water supply, and do not include the valley bottoms where most agriculture is located (Figure 17).

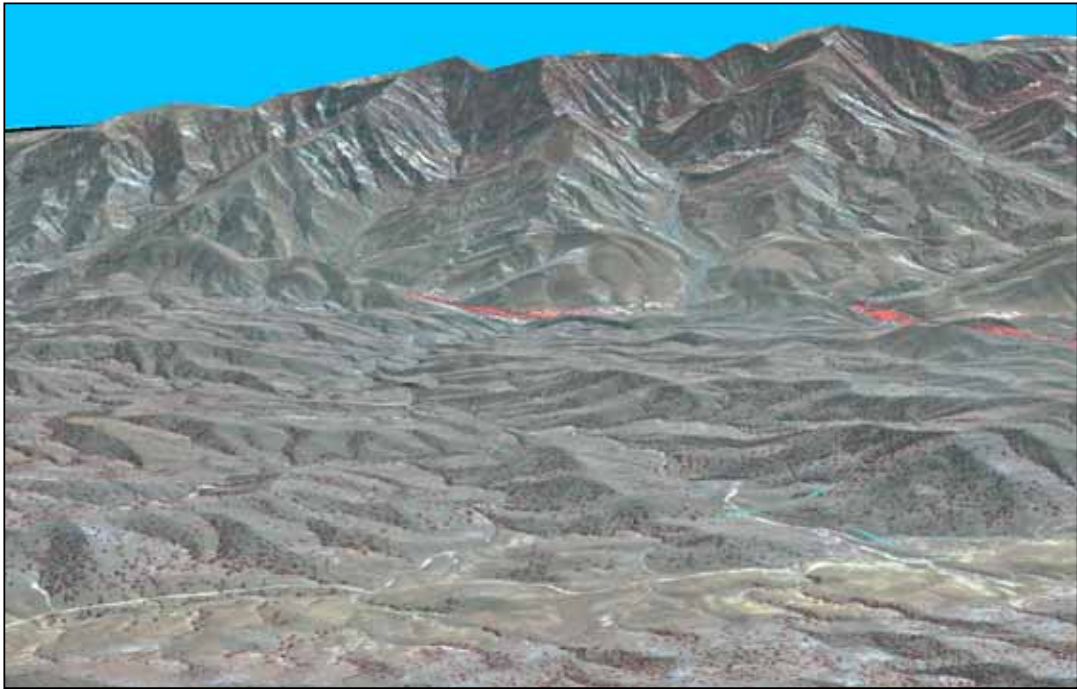
Figure 18. Mountainous Landforms in the East

Slope statistics for each watershed are in Table 8. The Carawna, Mangretay, Malaksay, Rawarkaray, Sur Zghamay2, and Banduray watersheds are quite steep, averaging over 28% in slope. Most are in the mountainous east (Figure 18). These watersheds also have the longest slope lengths, particularly near peaks. The remainder, in the western part, have a higher proportion of low hills (Figure 19), with average slopes between 10 and 23% (Table 8). An exception is Naway Pasana which is quite steep.

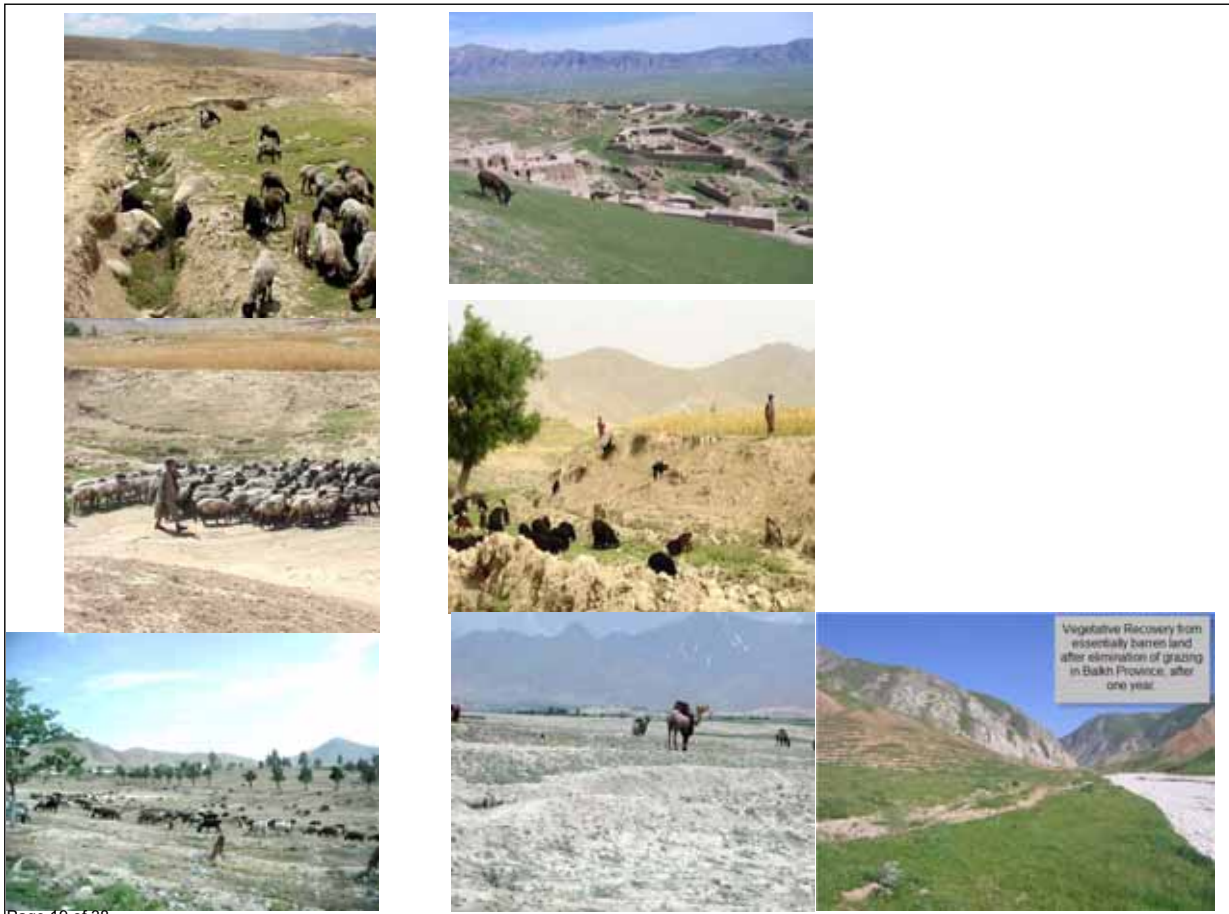
Figure 20. Images of grazing and soil effects.

It is very likely all suitable lands are heavily grazed season-long, with high utilization and relatively un-managed distribution (though most lands are high in terms of potential grass production). The effects of these practices have been reviewed, and generally concluded to cause excessive soil erosion and lowering of productivity, on a broad scale in Afghanistan (Fripp, et. al, 2006; Fripp, 2006; UNEP; 2003, Domian and DeCamp, 2007; Domian, undated). Figure 20 has sample photographs from these publications showing grazing practices and effects on soils. These are probably related to the critical social and environmental problems in-country, with most agrarian families struggling to survive with limited resources, and limited choices. Landcover for most watersheds is generally suitable for grazing (Table 10), so is concluded to occur in all watersheds.

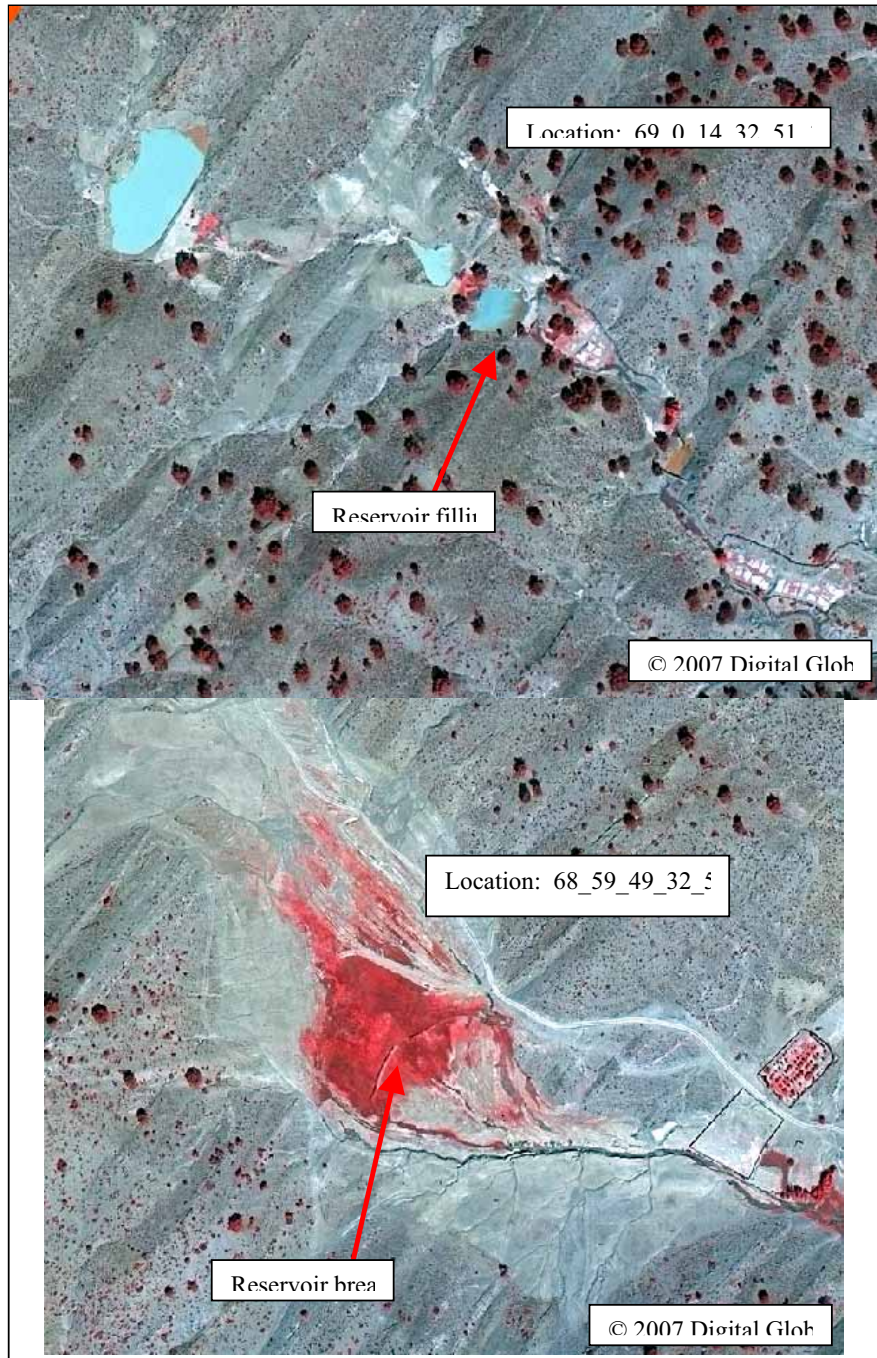
Figure 21. Images of Zama dams and reservoirs

Efforts have been made to improve waters management in some areas. In the Zama and Gol Kowt watersheds, upstream dams and reservoirs were identified, but the majority were filled with sediment or breached (Figures 21 and 22). This is a problem in other areas (Figure 23) This is likely due to poor management of the reservoir and watershed. (Johannes Oosterkamp, email communication).

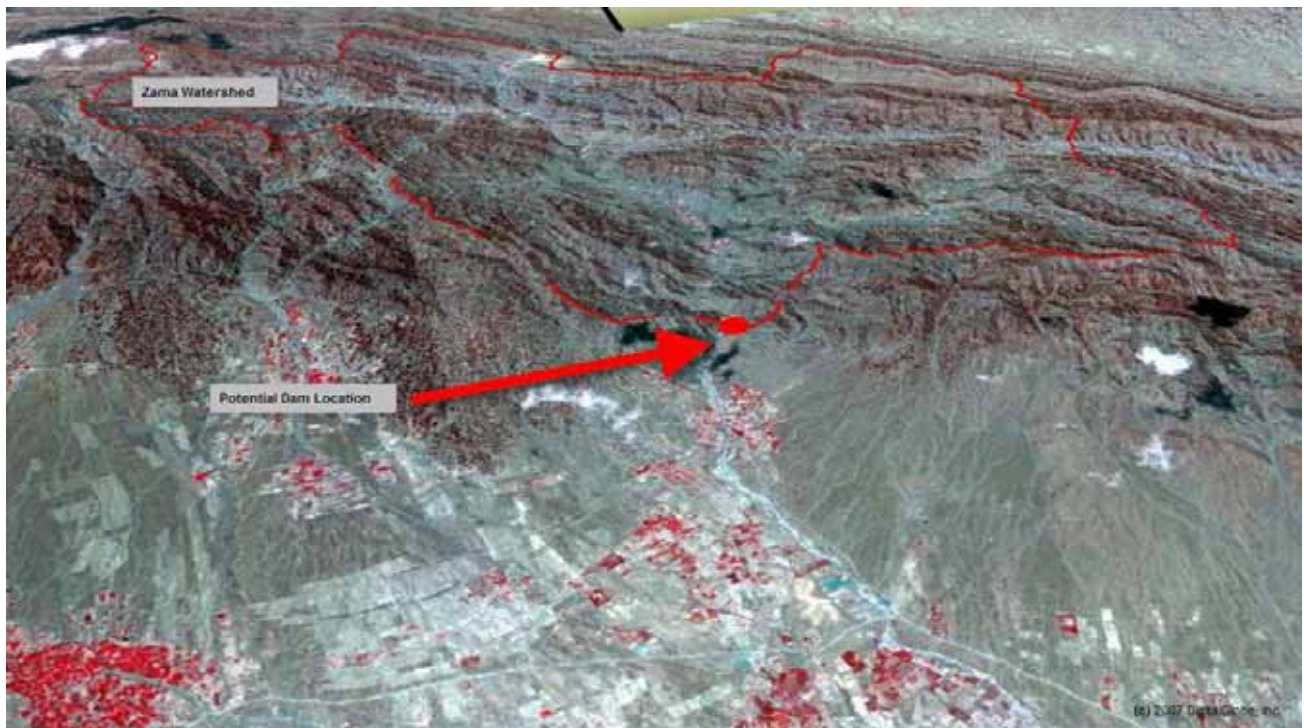
Figure 26. Perspective Overview of the Zama Watershed

This watershed is 5,219 ha (Table 1). An aerial canvass using the QUICKBIRD imagery verified landforms and stream systems are controlled by underlying bedrock structure, and surficial materials are weathered from siltstone and shale, with some sandstone on ridges. See Figure 26 for a perspective view. Soils are generally fine-textured and erosive, yet productive when irrigated. The potential dam location is at the base of the watershed, just above the depositional zone (Figure 27).

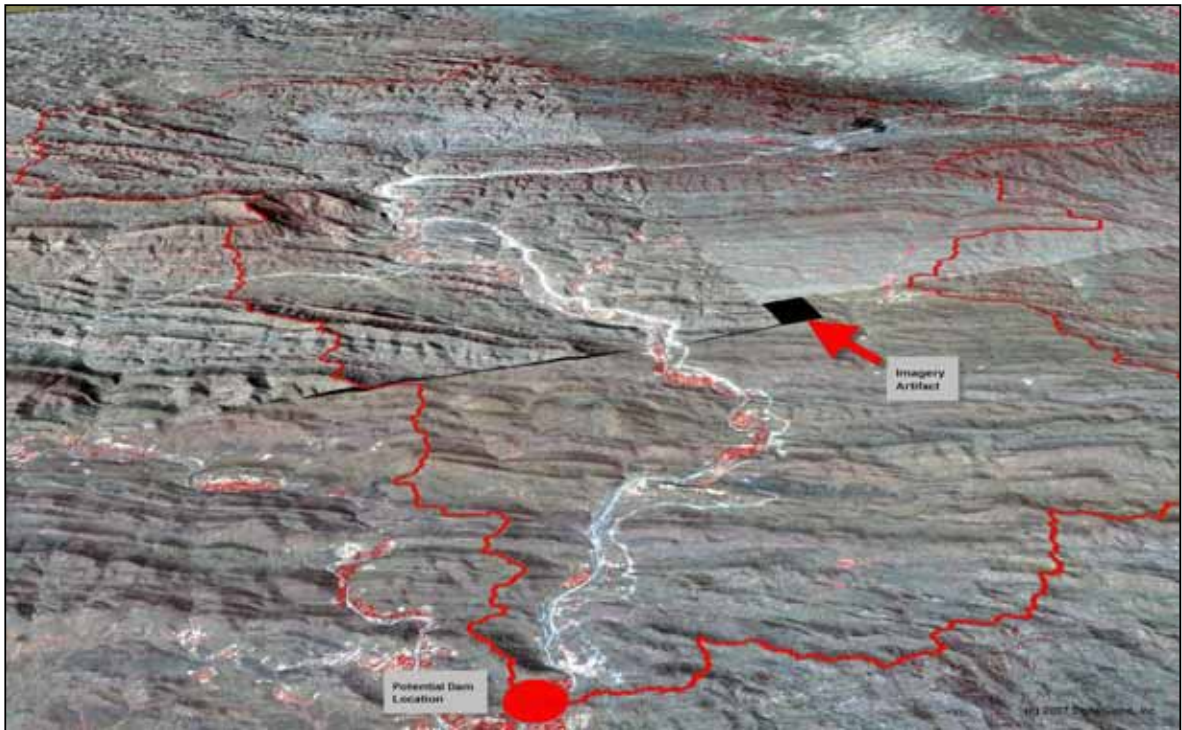
Figure 29. Perspective Overview of the Gol Kowt Watershed

This watershed is 15,151 ha, about three times larger than the Zama watershed. An aerial canvass using the QUICKBIRD imagery verified landforms and stream systems are controlled by underlying bedrock structure, and surficial materials are weathered from siltstone and shale, but harder rocks appear to be more extensive than in the Zama watershed, with sandstone or intrusive rocks on ridges influencing about 1/3 of the topography. See Figure 29 for a perspective view. Soils are generally fine to medium-textured, and less productive, harboring more sparse forest than in Zama's case. The potential dam location is at the base of the watershed, just above the depositional zone (Figure 30).

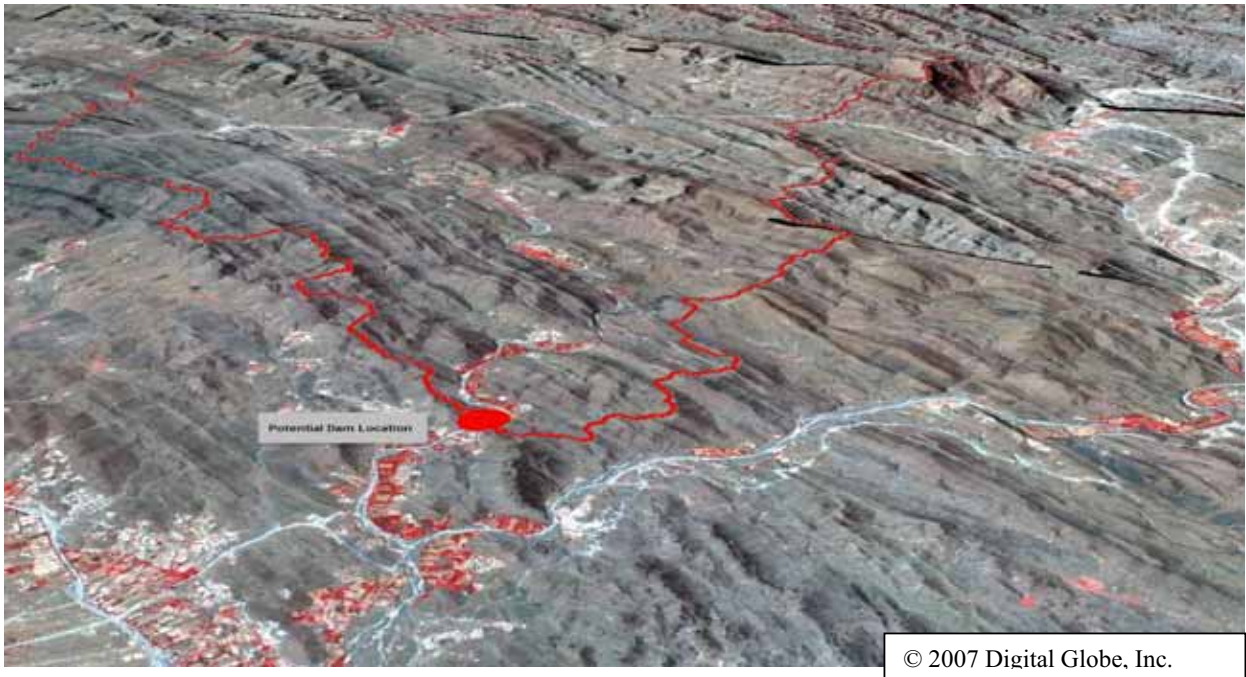
Figure 32. Perspective Overview of the Dawlat Kot Watershed

This watershed is 6,858 ha, similar to the Gol Kowt watershed. An aerial canvass using the QUICKBIRD imagery verified landforms and stream systems are controlled by underlying bedrock structure, and surficial materials are weathered from siltstone and shale, but harder rocks appear to be extensive in the watershed, with sandstone or intrusive rocks on ridges influencing about 1/2 of the topography (Figure 32). Soils are likely generally fine to medium-textured, and less productive, harboring more sparse forest than in Zama watershed. The potential dam location is at the base of the watershed, just above the depositional zone (Figure 33).
