South East Afghanistan Water Resources Assessment
Matun Area Field Support
Henry Shovic
May 1, 2009

The objective of this set of maps is to help ground personnel focus on watershed and dam issues in four project locations in the Matun area, Shamal sub-basin, SE Afghanistan.

Southeast Afghanistan Water Resources Assessment: Shamal Sub-Basin, Matun Area Projects Points of Interest

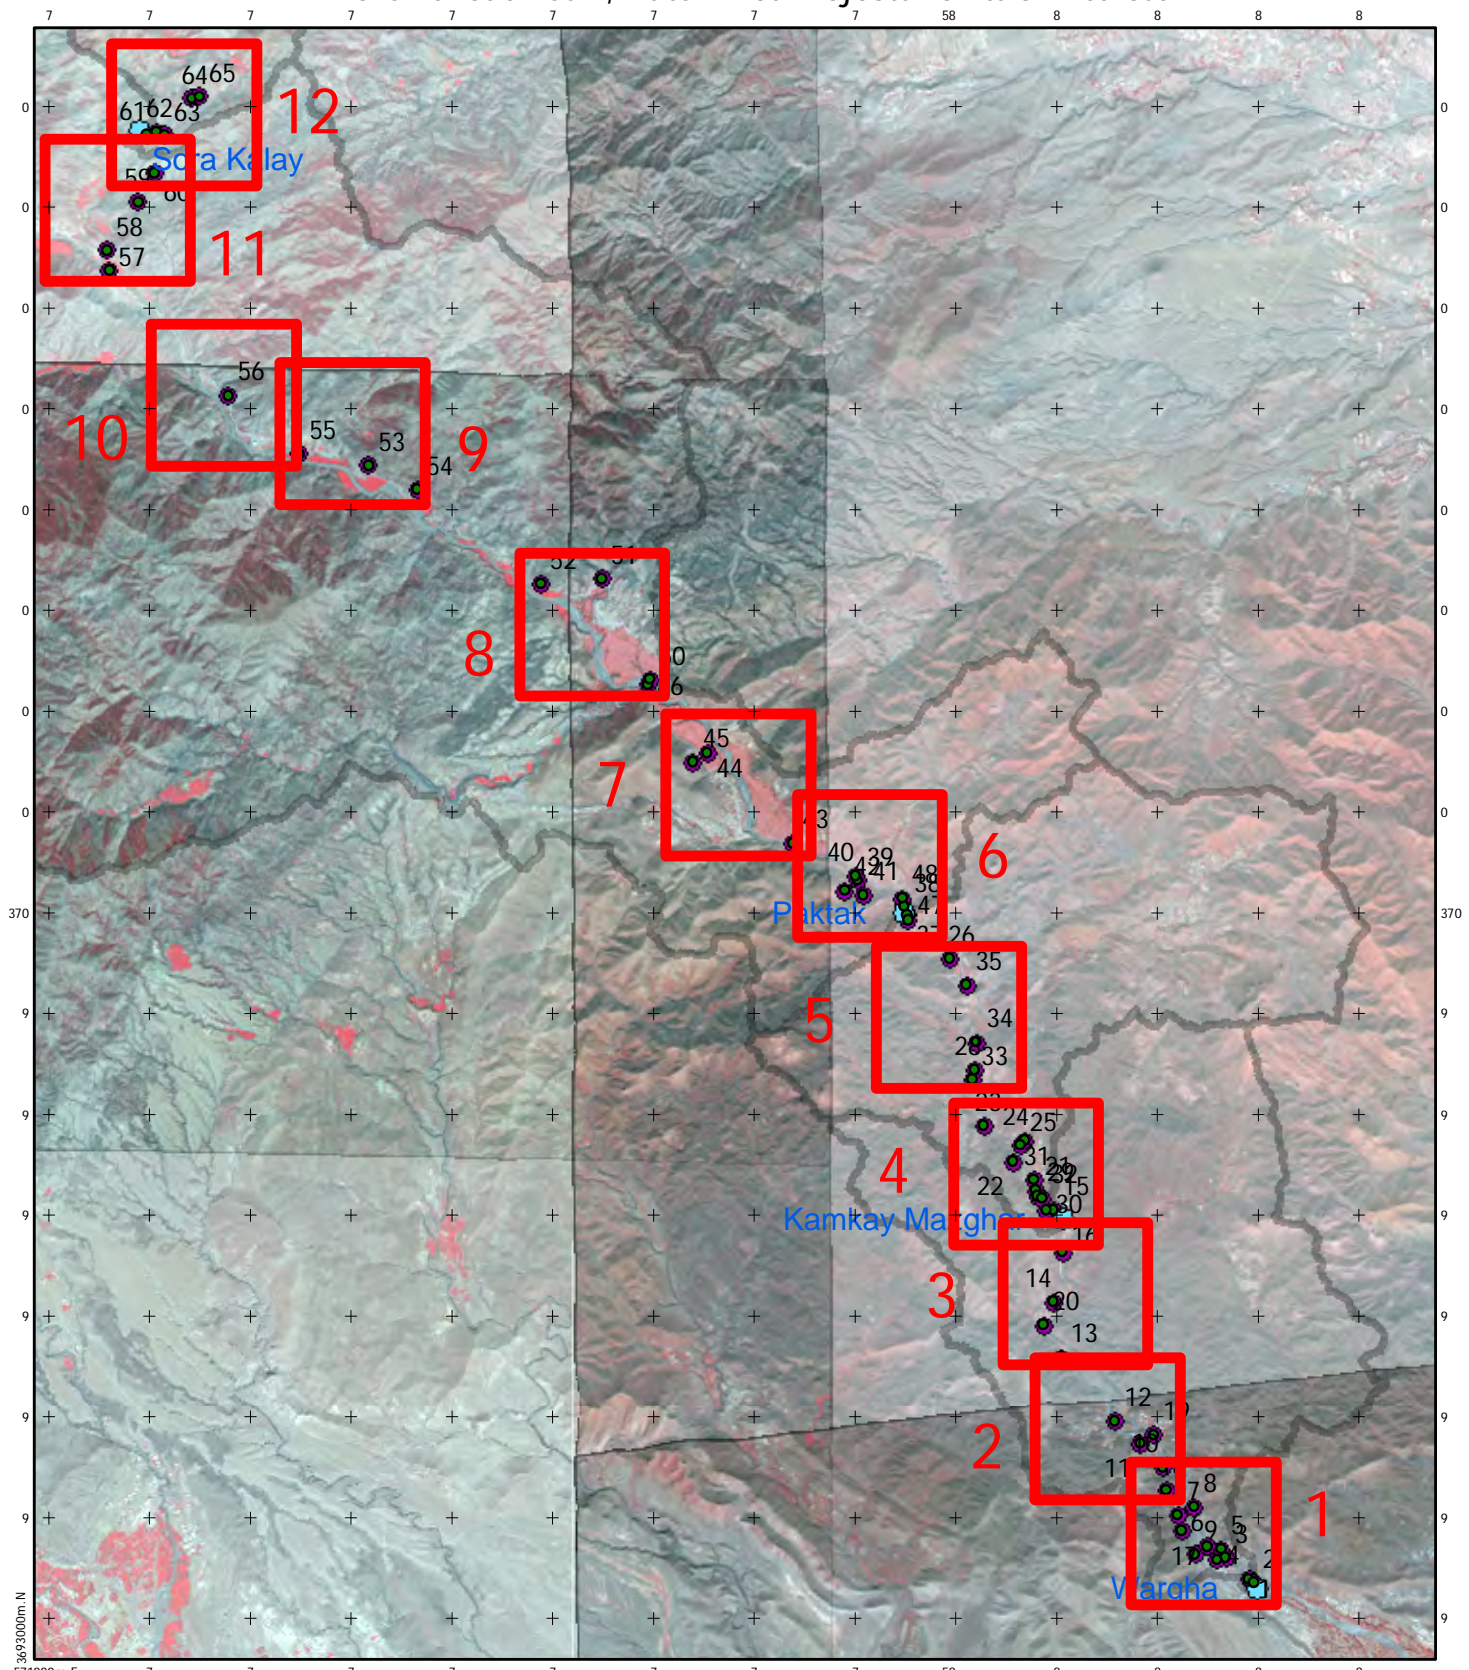
This map's objective is to show four water resource improvement projects, parts of their associated watersheds, and a list of field sites illustrating various aspects of watershed and dam location procedures. See additional maps for closeups, framed in red.

There are 62 POI's (Points of Interest) suggested to help the team on their field excursion. They relate to project feasibility, logistics, benefits, impacts, and watershed conditions in the area. All are close to major access roads, though low water crossings may affect access to the northern ones.

Most POI's are of a general nature. That is, the marked point represents an area, not a specific feature. Features are noted where it is important to find a location on the ground. Please take a photo at each point to document findings, as this will help the Stateside team verify the remotely-sensed data. The following table lists all the points, descriptions, and LATLONG locations. The attached maps show the entire Matun area. Detailed maps are also included to facilitate location on the ground.
