Project Report: Canyon Lands Fort Bottom Trails  
Field Review, Analysis, Conclusions, and Recommendations  
Henry Shovic, PhD  
Rocky Mountain Cooperative Ecosystems Study Unit  
Mar 4, 2009

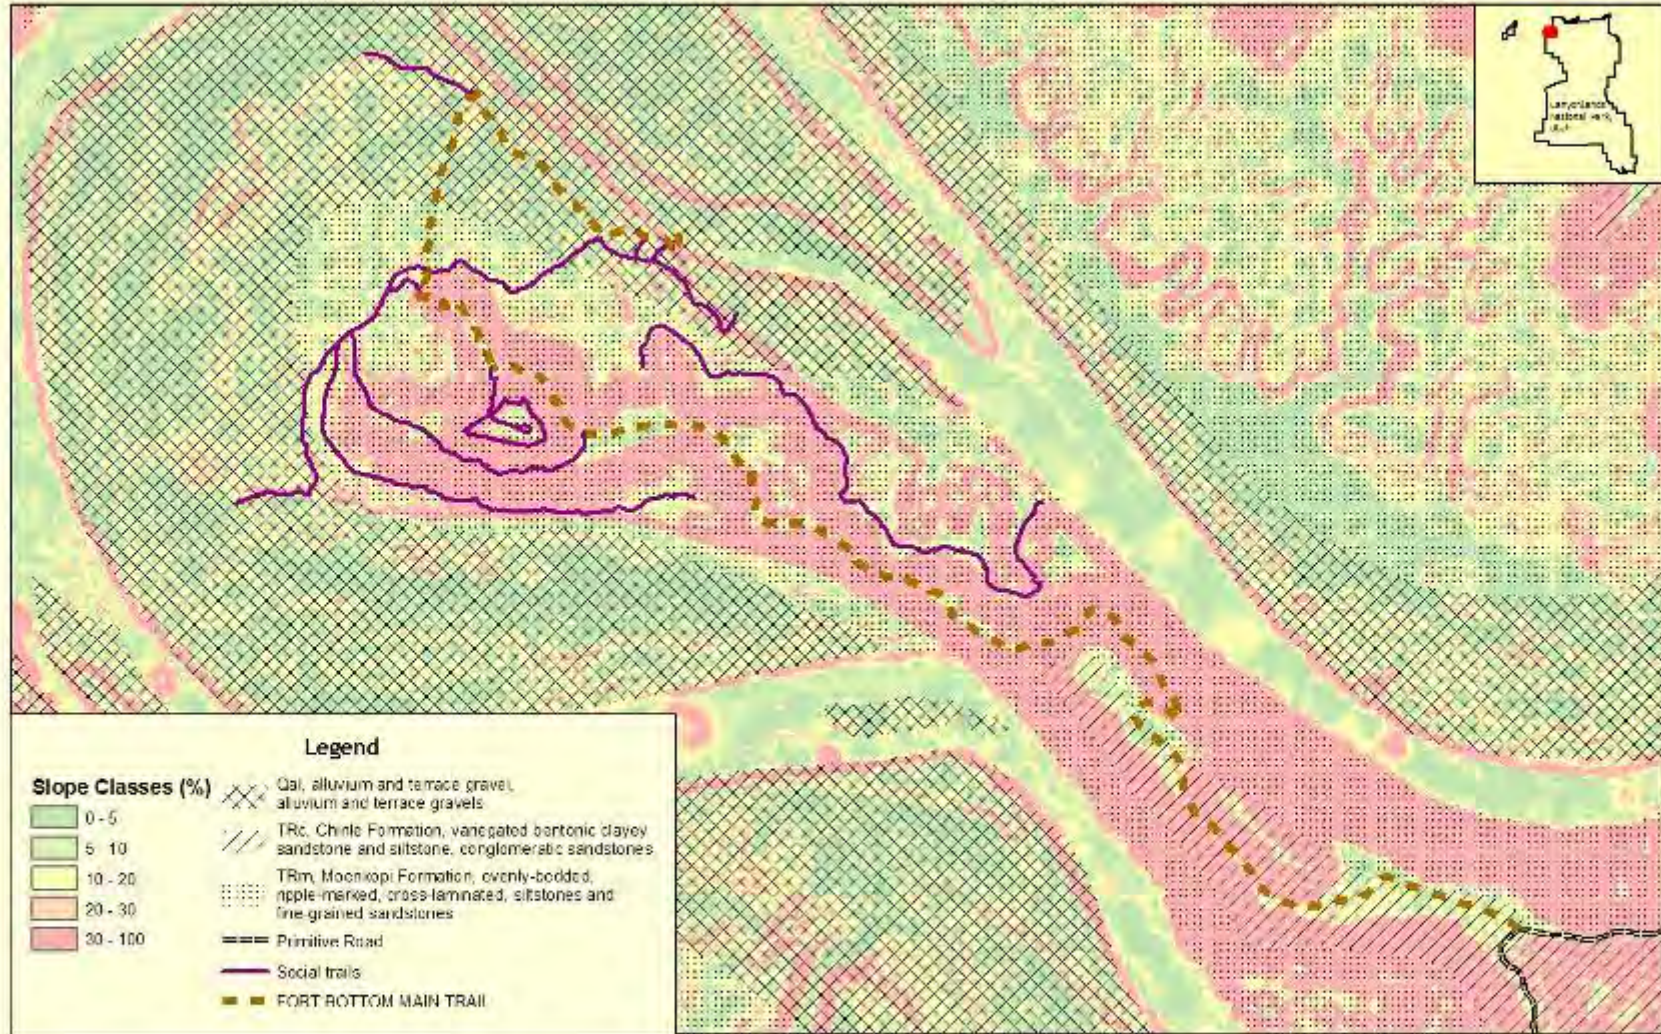
Figure 3. Fort Bottom Area Geology and Slope

Most of the steeper area is mapped as Moenkopi Formation (siltstones and fine-grained sandstones) (Figure 3) The Chinle Formation (sandstone and siltstone, conglomeratic sandstone) caps the narrow ridge and associated rocky sideslopes). Coarse-textured alluvium occurs near the river.

Cirque 3 and Cirque trails both are rated as being in “Poor” condition, as well as being highly sensitive. They are both on very steep slopes, and are in the erodible Moenkapi formation (Figure5, 6).

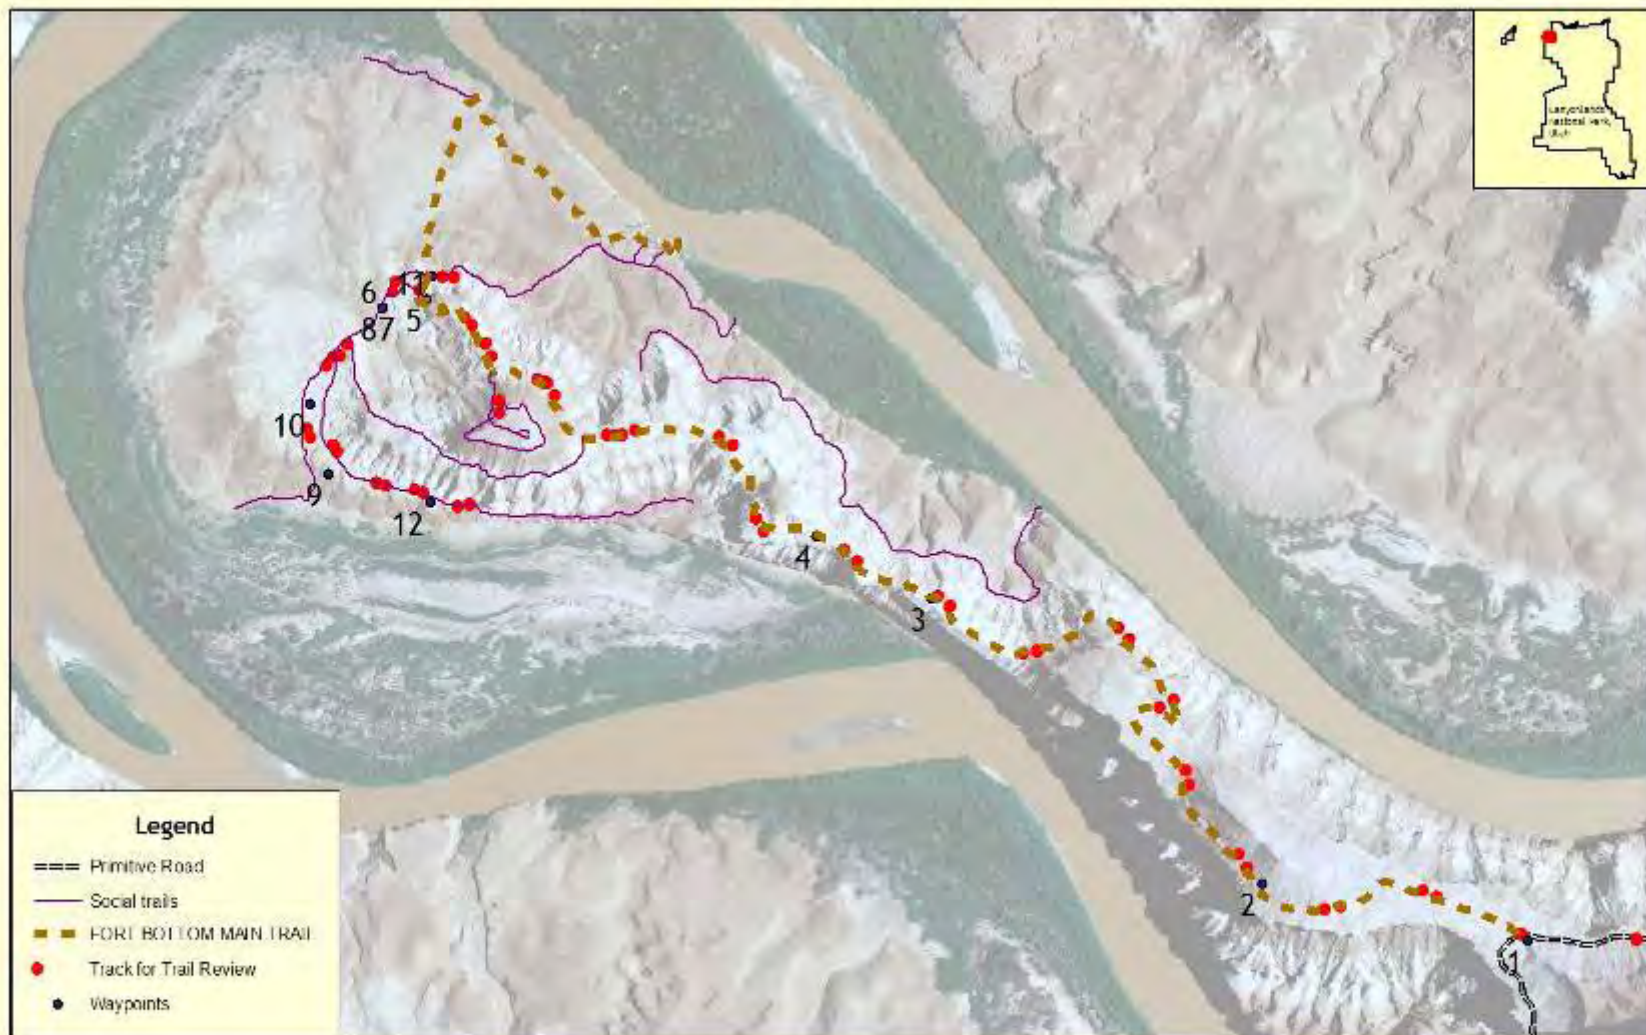
# Canyonlands National Park Fort Bottom Area: Trail Review Data

WP 12 on contour; trail has almost disappeared due to slough. Sideslopes up to 40%; hazardous to walk on; in friable, erodible weathered shale (silty); soil is nearly barren.

Picture looking back at the red-rated trail near WP 12; close to WP 4; pic 201 Hard to see tread, because highly erosive soils have covered it.; self recovering; no recent use this year; possibly should be barricaded or signed.
