Project Report: Canyon Lands Salt Creek Road
Field Review, Analysis, Conclusions, and Recommendations
Henry Shovic, PhD
Rocky Mountain Cooperative Ecosystems Study Unit
May 3, 2009

This document addresses Objective Two in the agreement “to provide alternative development analysis and support” for three project areas as designated by NPS staff. This report focuses on the Canyonlands Salt Creek road.

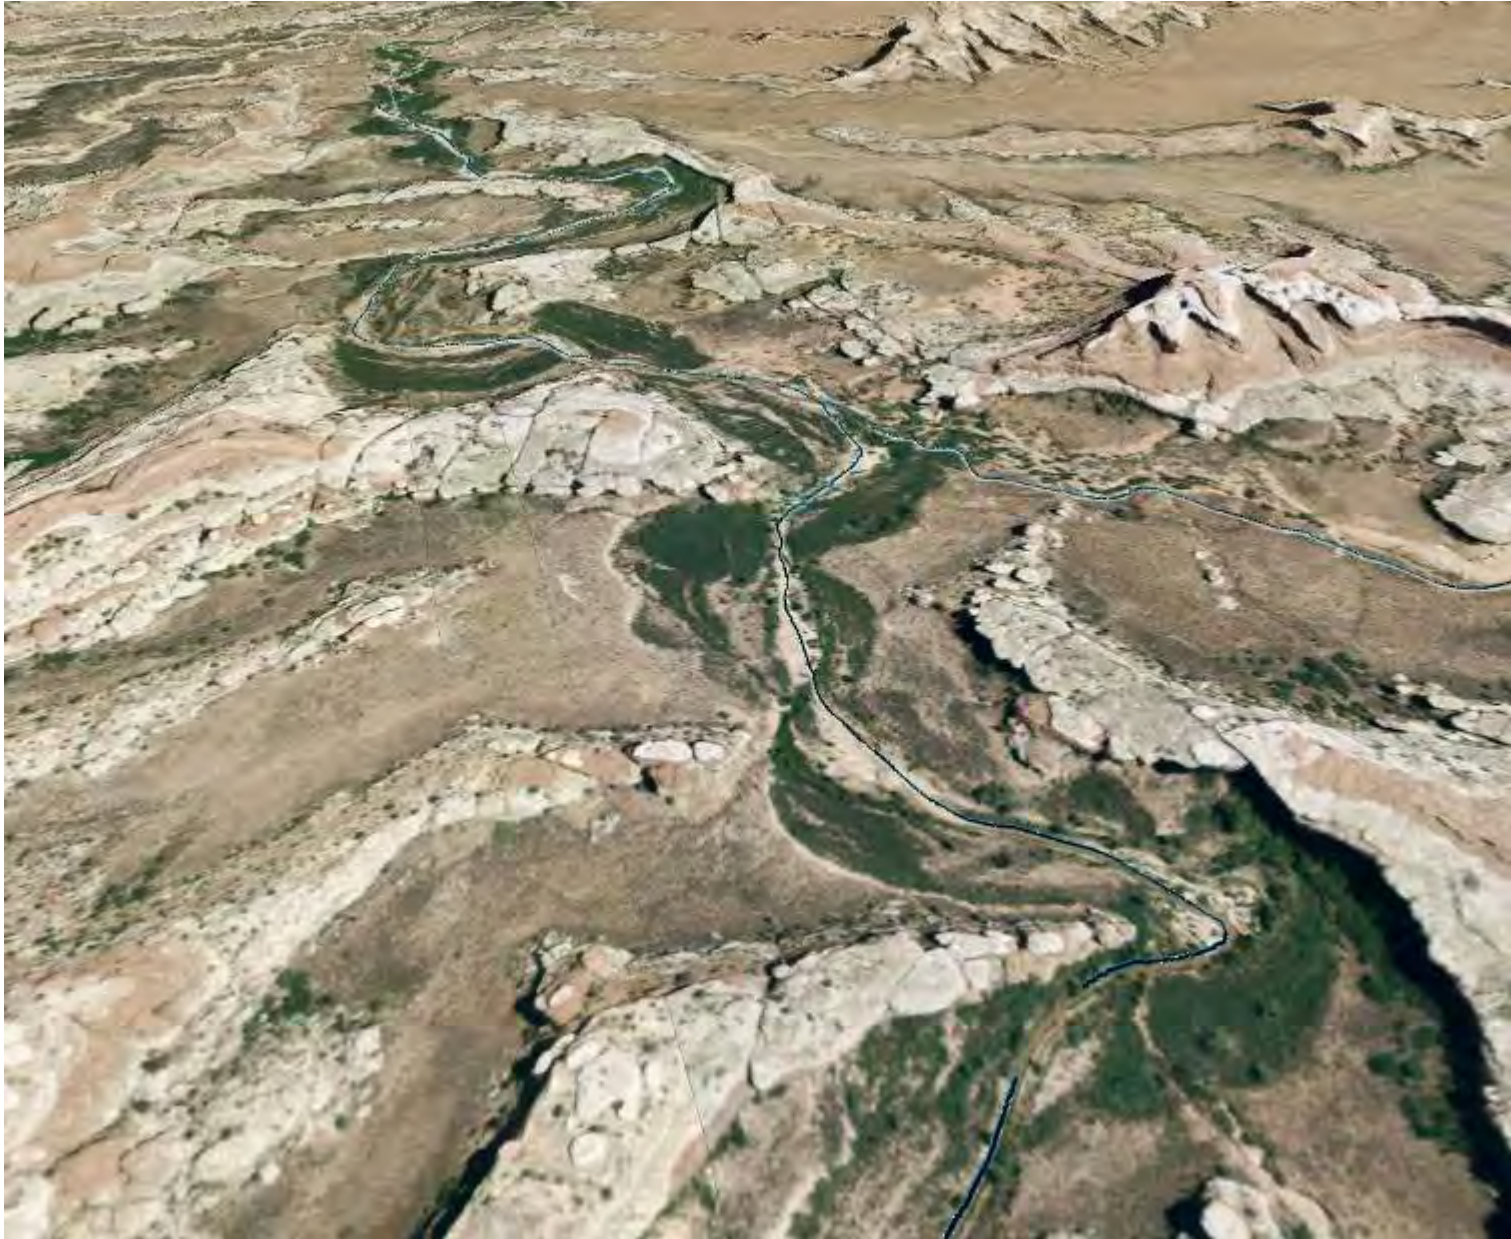
Figure 1. Landscapes of the Salt Creek Road Area, looking from south to north.

Figure 1 shows the landscapes of the Salt Creek valley (looking from South to North). Slopes are gentle to steep, with the main road following a following a vegetated stream course and associated flood plain. Uplands are derived from the Cedar Mesa Sandstone with very sandy regolith, and most of the lowland is composed of very sandy alluvium and wind-deposited sand with some river gravels. The road itself is about 3 miles long. About 80% is in the active stream channel of Salt Creek. Flooding is apparently common and significant.

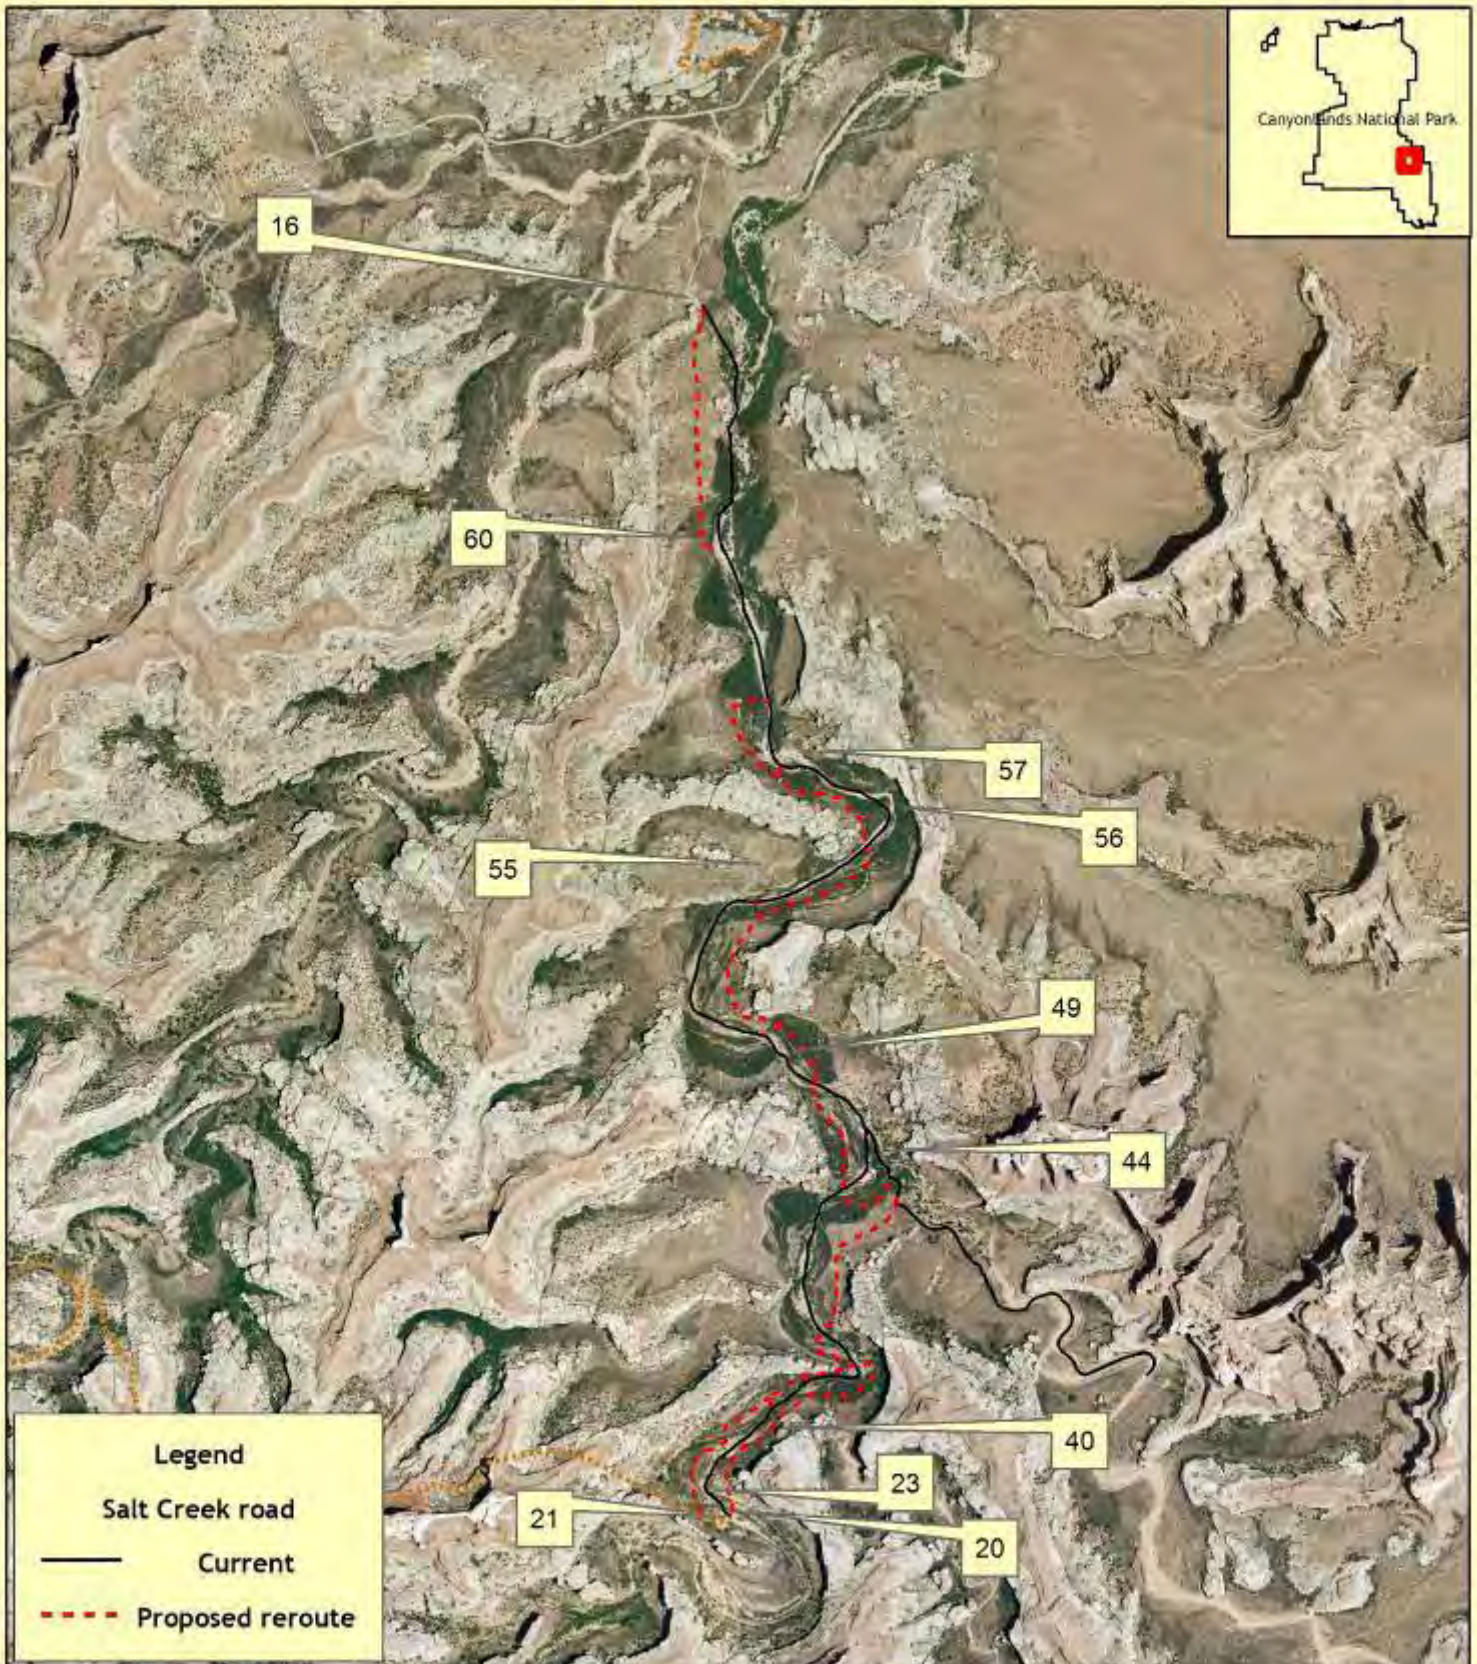
Canyonlands National Park: Salt Creek Road Review

Figure 2 shows the project area and salient review analysis by location. It is based on the data in Appendix One. See the following discussion for each marked point or area.

The current road follows the active stream channel in the Floodway for 80% of the project area from the gate (Point 16) to the closed gate near Peekaboo Campground (Point 20) (Figure 2). A proposed re-route of the road is shown in Figure 2 (red dashed line). The re-route follows terraces surrounding the current road, with at least four intersections with the stream channel/current road.

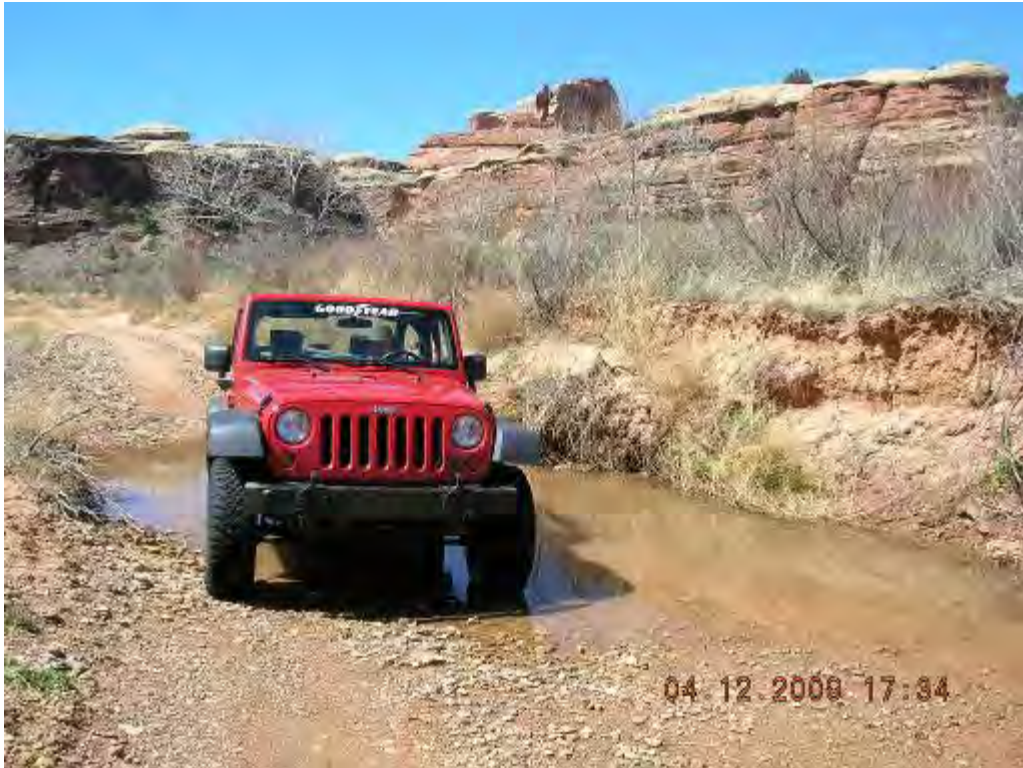
- The Floodway (including the active channel) has no vegetation and probably flows every year.

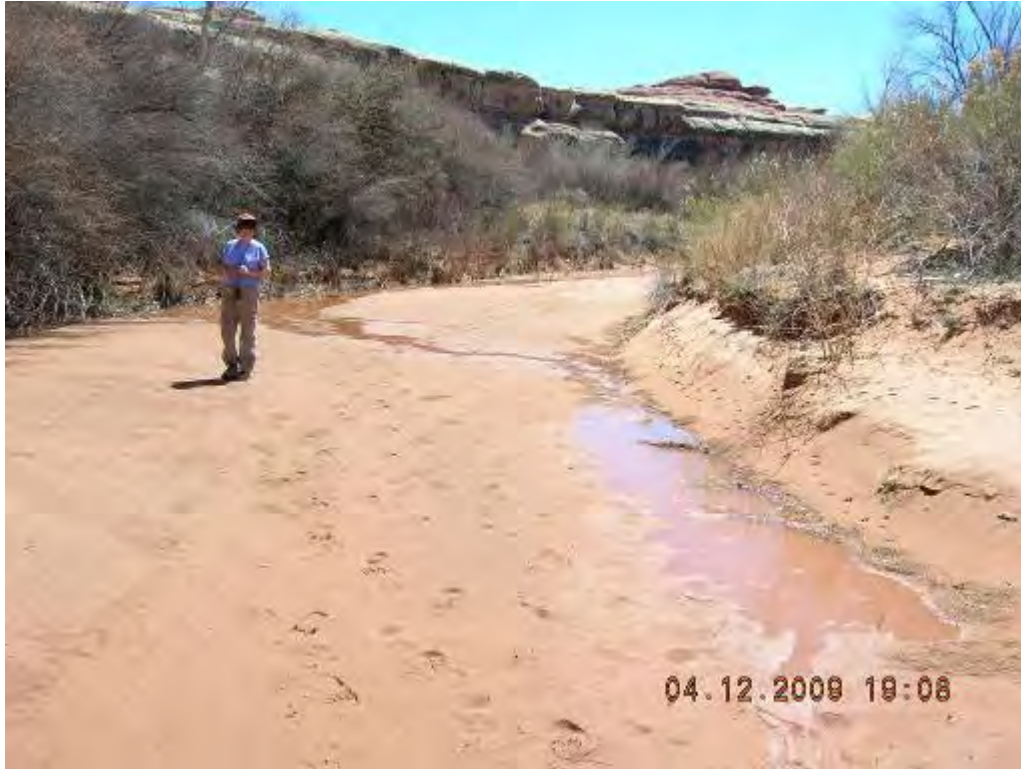
Stream channel characteristics appear to be different in areas without the impacts of vehicle traffic. At Point 56, a segment of stream channel shows no evidence of vehicle use. The channel is significantly different than the nearby road/channel. No large holes or unconnected pools occur in the un-driven area. In nearby stream channels with no apparent vehicle use, vegetation is present in the channel and it is less disrupted by large holes.

Stream character without vehicle use

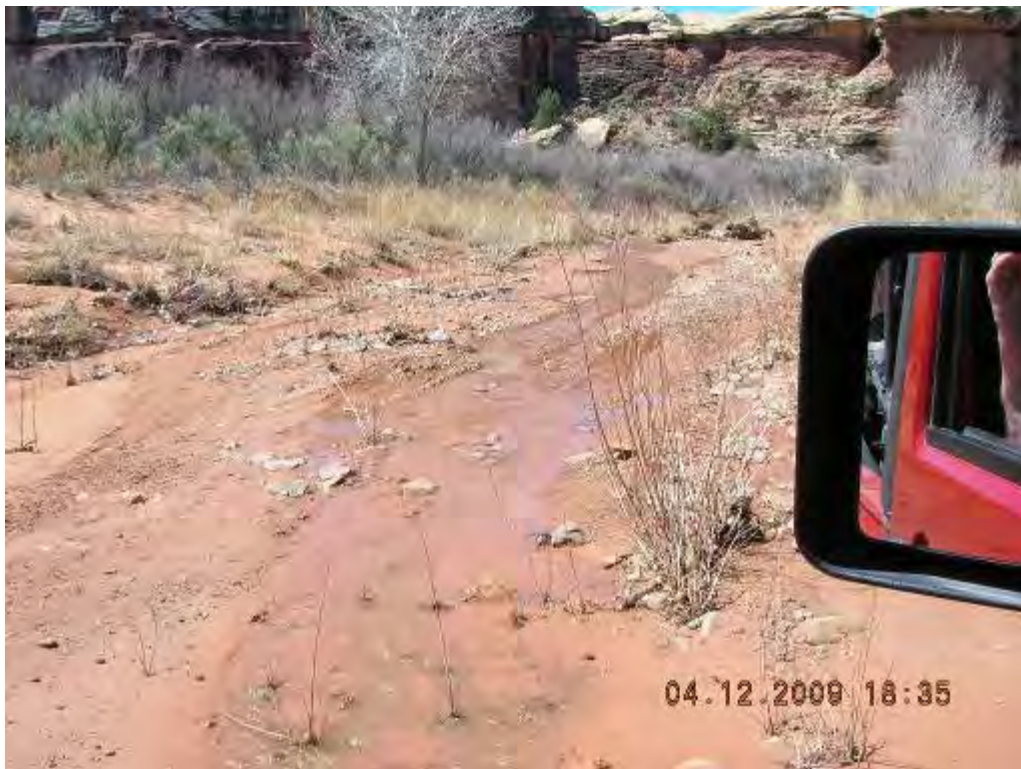
Stream character and vegetation without vehicle use

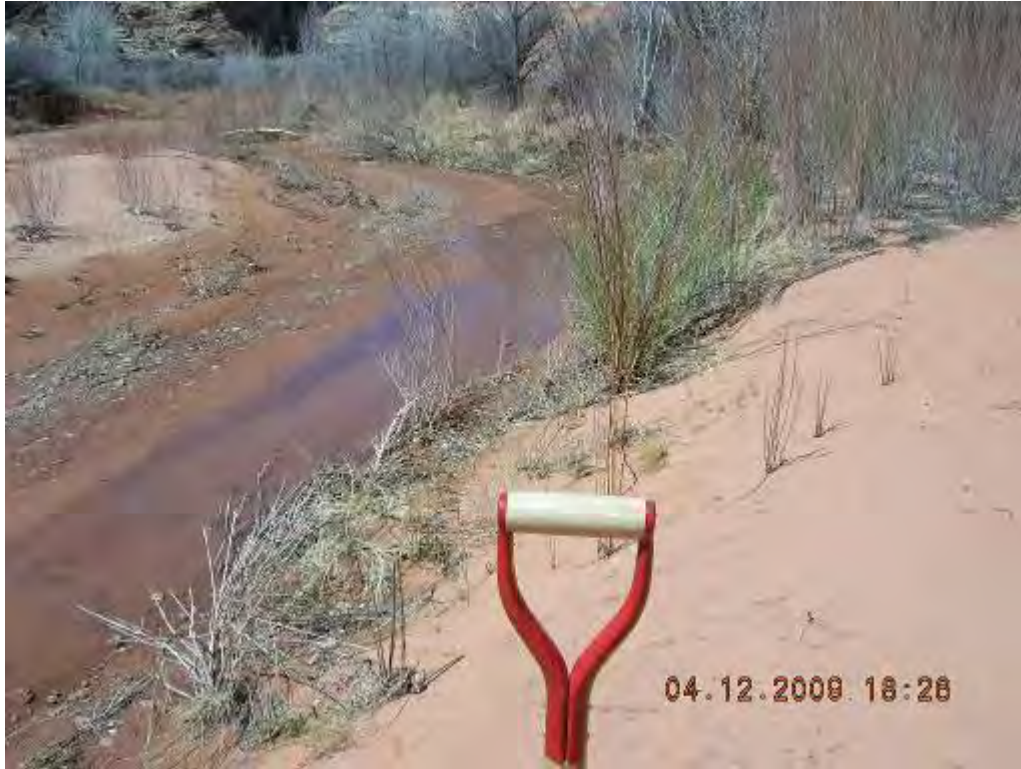
Stream character and vegetation without vehicle use

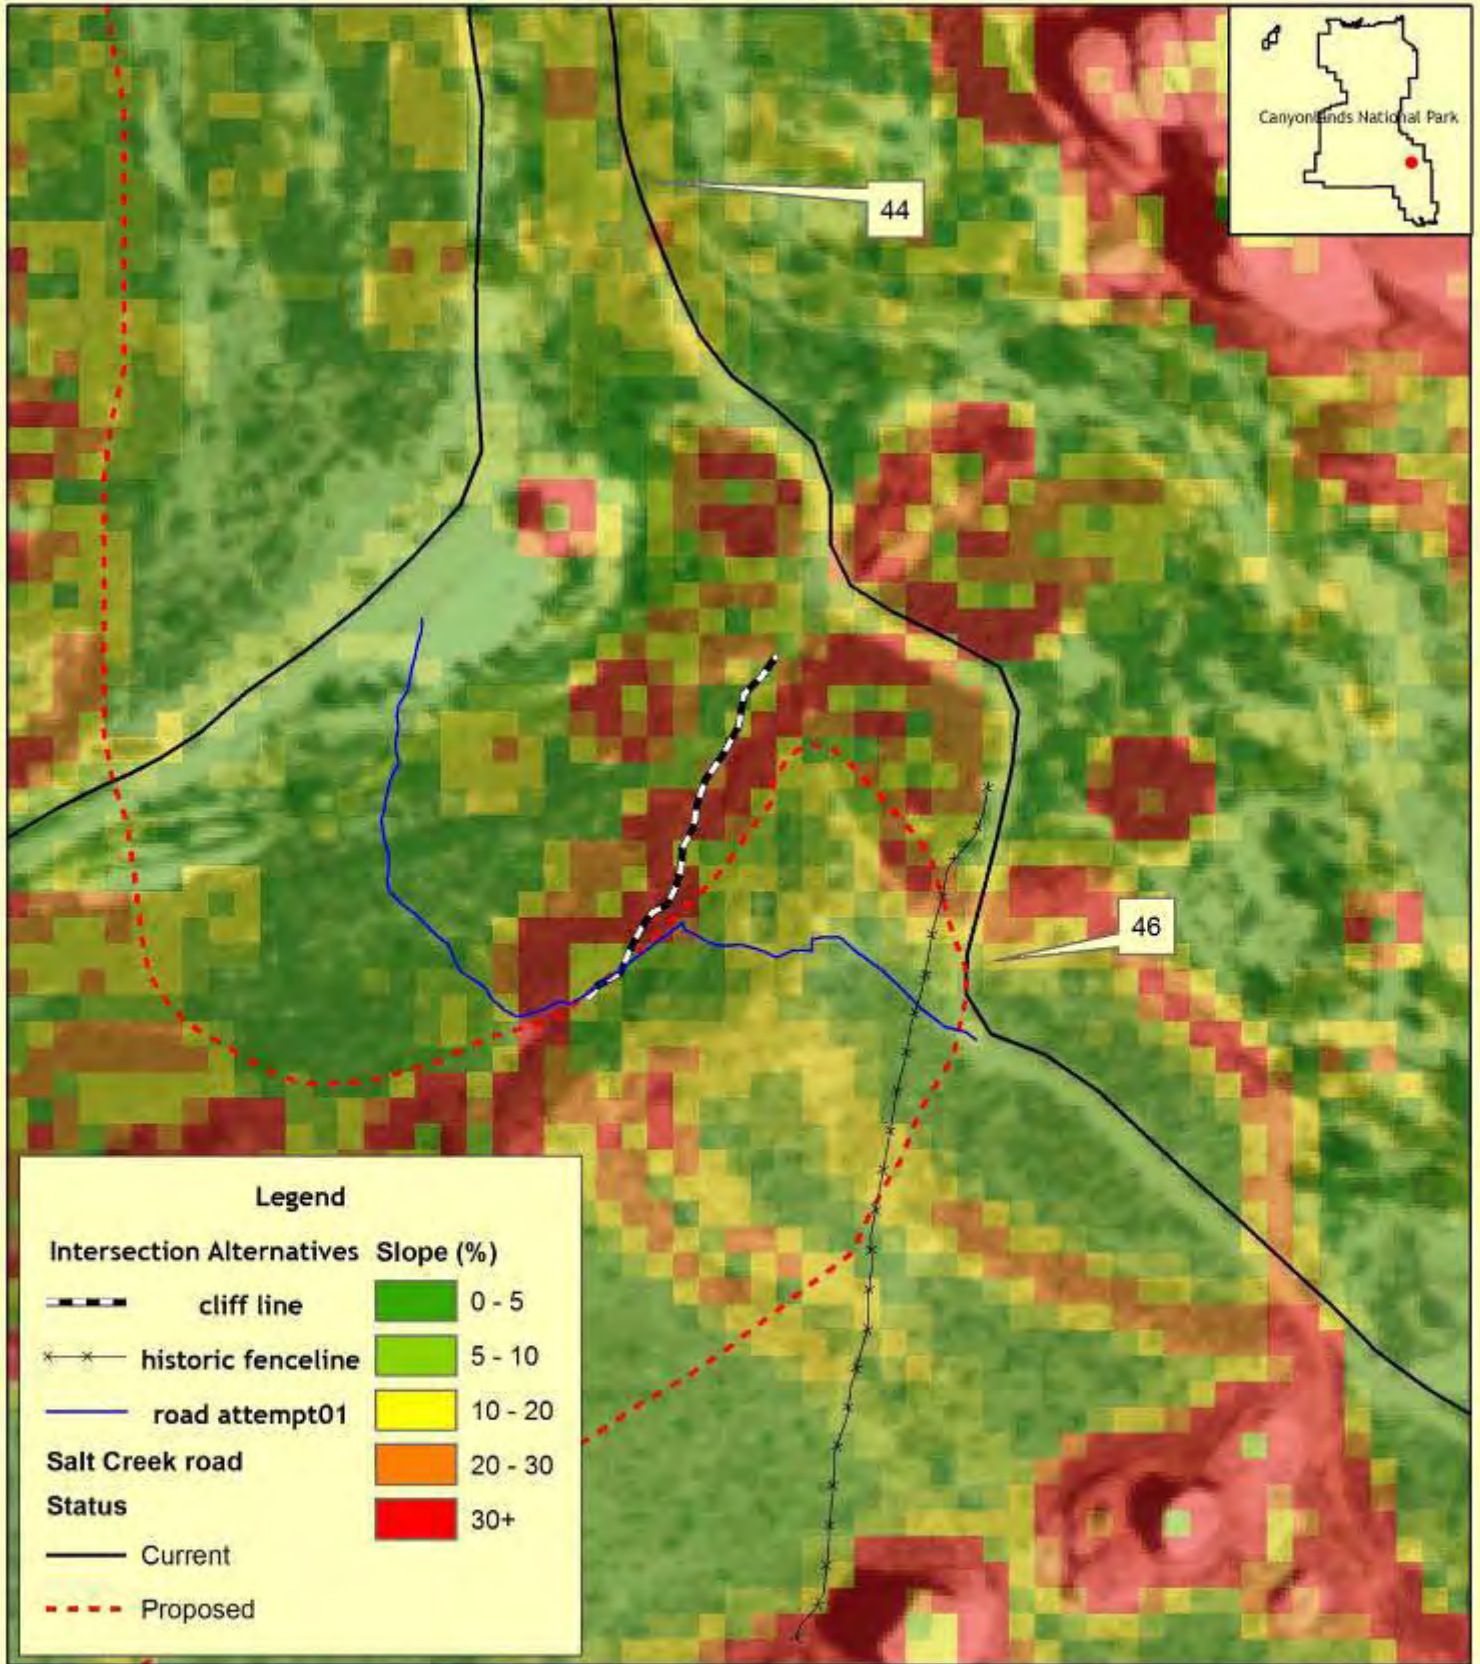
Canyonlands National Park: Salt Creek Road Review

A particular potential problem area was identified on the Horse Canyon road (Point 44 on Figure 2).

Two potential reroutes have been identified (blue and dashed red in Figure 3). Each appears to have potential to avoid the current road location, but both come very close to an observed cliff line, which probably extends south past the symbolized location on Figure 3, based on the aerial imagery. Both also appear to traverse steep sandy bluffs (slopes $> 30\%$).
