RC-East, Eastern Afghanistan, GA-ADT, Logar Province, Pul- e' Alam District, DAIL-Pul- e' Alam Watershed Restoration/Agricultural Water Resource Improvement Project (Including Hillside Treatments)

Henry F. Shovic, PhD

Jan 13, 2012

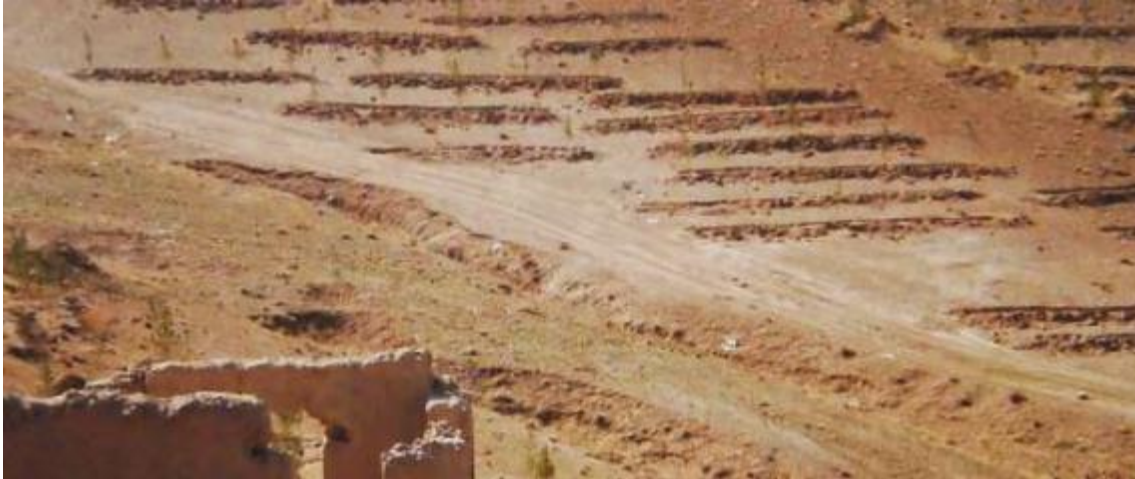
Figure 1. Hillside Ditches near Pul-e' Alam (image by U. S. Army)

There are some Karez systems and an apparent ditch-oriented water collection system in the area. An extensive hillside ditch treatment has been installed before 2007 (the date of our imagery), with the apparent purposes of reducing erosion and flooding effects on the major canal and to accommodate tree plantings (Figure 1). This is about 30.8 ha in size and emphasizes the lower part of the watershed (Figure 2.). The benefits of this watershed treatment can be enhanced by using infiltration (check) dams in ephemeral and intermittent drainages having only small active channels. These are specified below.

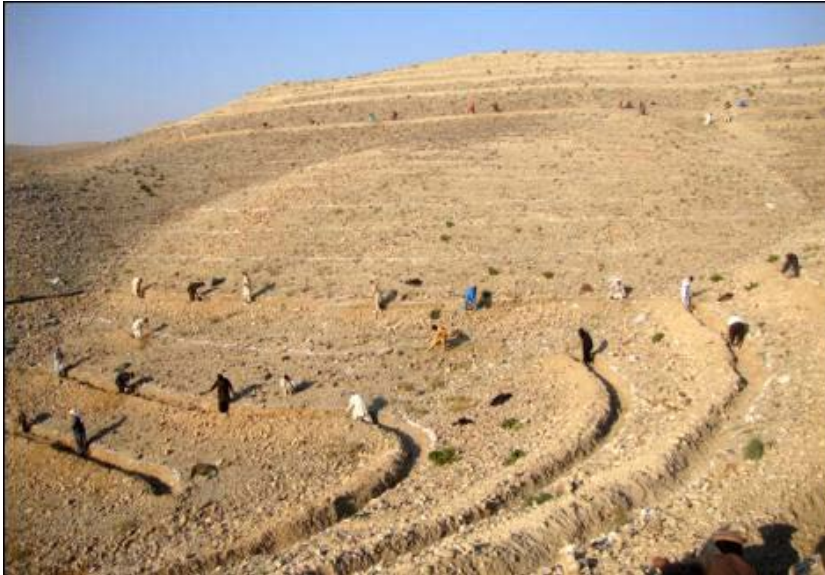
Figure 3. Example Hillside ditches (image by AWATT)

Hillside ditches and rock bunds (hillside ditches made of stones) are generally used for reducing runoff (Example in Figure 3). They are placed on hillsides to intercept runoff and provide opportunities for increased infiltration.

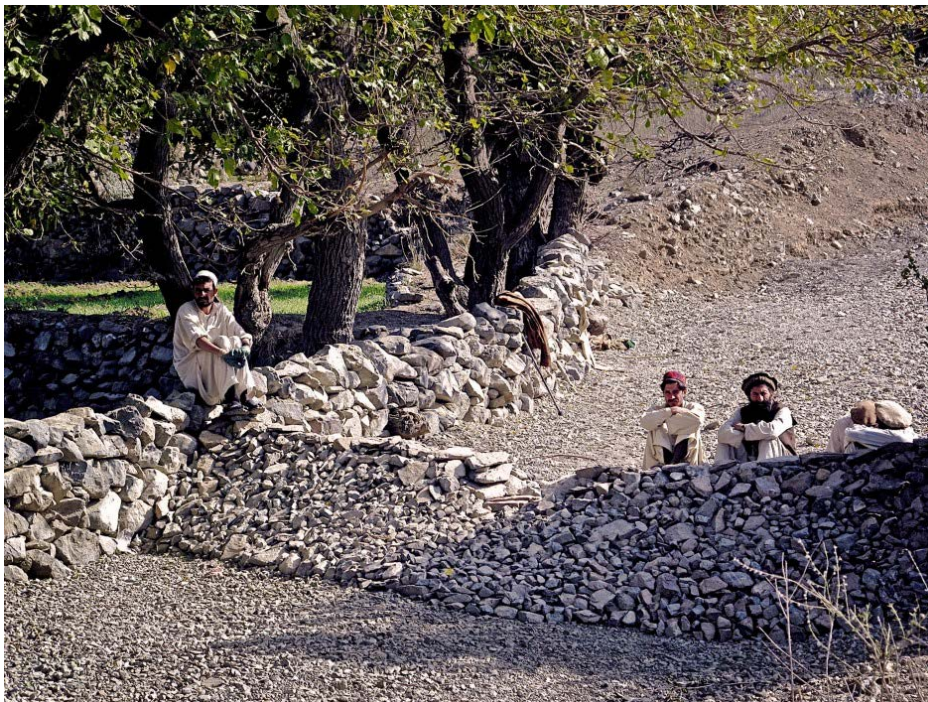
Figure 5. Example of an Afghanistan Check Dam (image by U. S. Army)

Infiltration check dams (Figure 4) are normally used for gully restoration and there are gullies in this project area. However, there are also many ephemeral or small intermittent drainageways that could benefit from check dams to increase infiltration by slowing water flow (Figure 5). These are not specified in large intermittent or perennial stream channels, because of potential hydrologic disturbance of the channel and washout potential. They are also restricted from areas where drainageways are used for irrigation or directly above habitation. They are placed only where drainageway slopes are less than 20% to avoid blowouts and associated erosion.

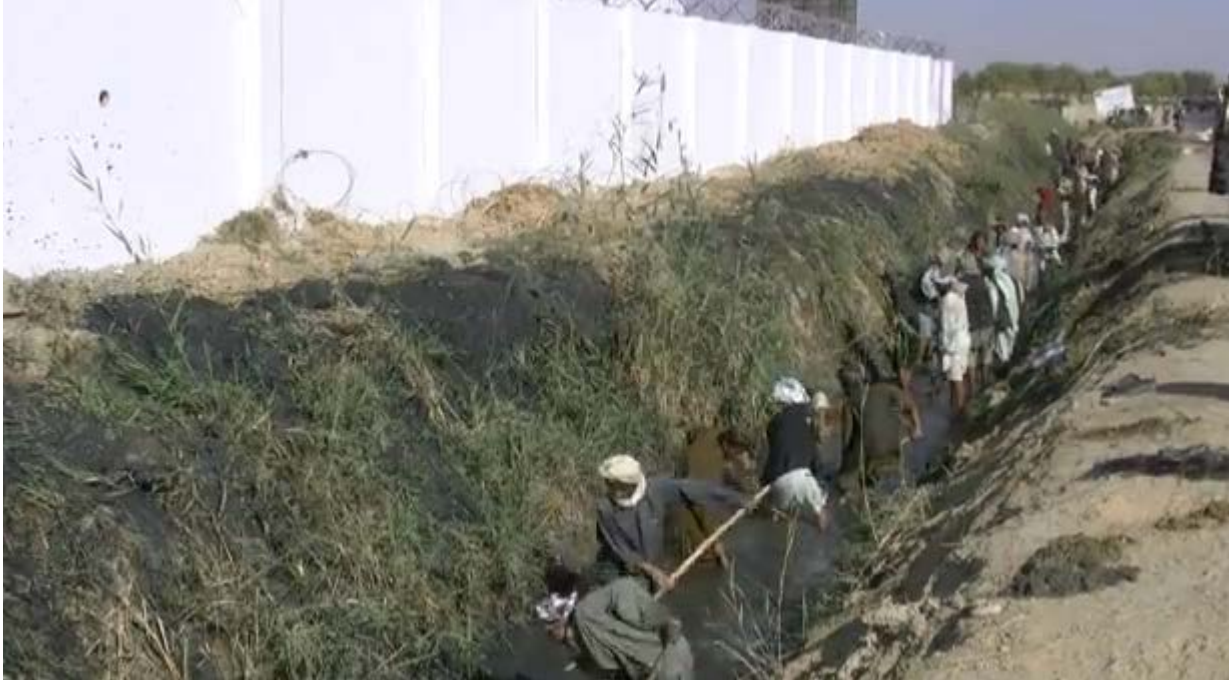
Figure 6. Canal Cleaning (Image by USAID)

Only one canal was mapped here, and is a major feeder for many agricultural uses. It appears that it could benefit by seepage reduction, grade control, silt removal, and breach repair (Figure 6). De-silting, vegetation removal, debris cleaning, and rebuilding weak sections look like good activities that would benefit the irrigated agricultural areas farther downvalley.

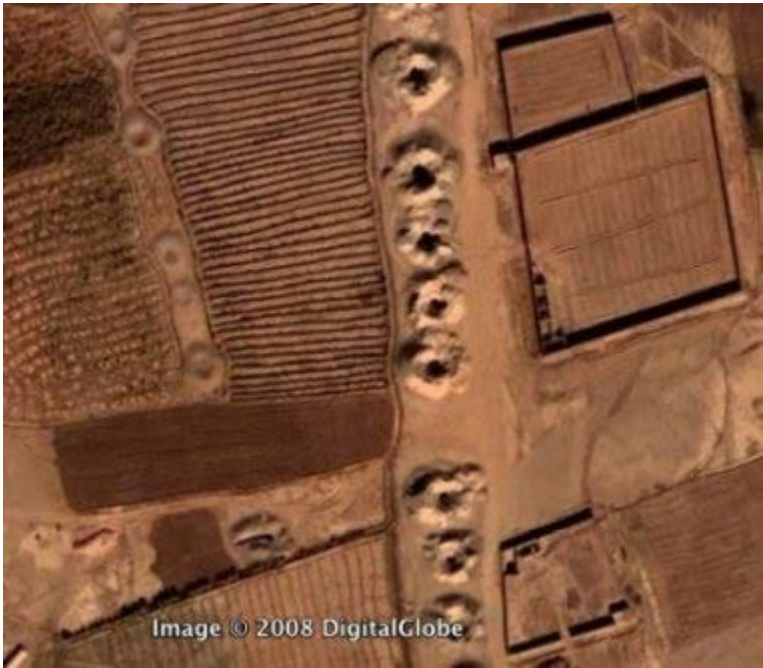
Figure 7. Aerial view of Karez (Image from Registan.net)

Karez systems are traditional irrigation systems using a series of pits accessing subsurface channels (Figure 7 and Figure 8). There are three totaling 350 m in the Study Area. These could probably benefit from cleaning. See the detail map for locations.
